## **CONFIDENTIAL HOME INSPECTION REPORT**

Property Inspected:  
Sample St S., Cottage Grove, MN 55016

Prepared for: Sample  
Report Number: 5014A  
Inspection Date: 7-3-2010, 2:30 PM  
Inspected by: Tim Walz  
Suburban Home Inspections, Inc.  
[www.homeinvestigator.com](http://www.homeinvestigator.com)

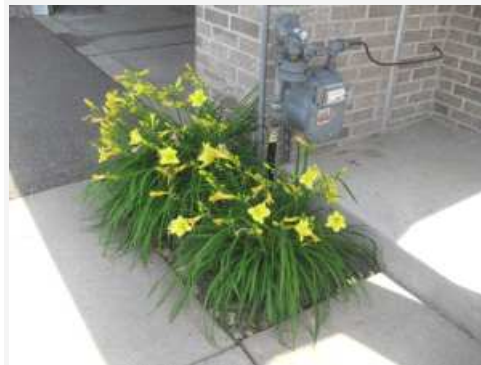
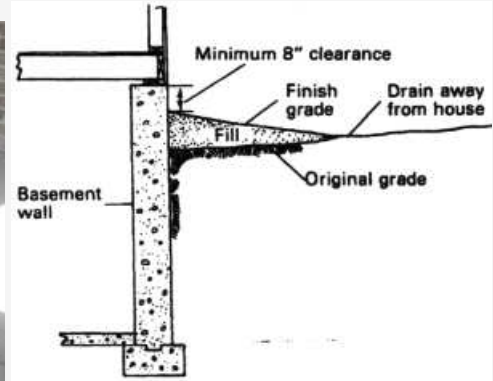
**GRADING:** The grading is negatively sloped toward the home in one location - at front entrance area. A positive slope of 2.5" per ft., for a minimum of 10', is recommended. Flat or negatively sloped grading allows rain water to accumulate near the foundation walls, which increases the chance for moisture to leak into the home.

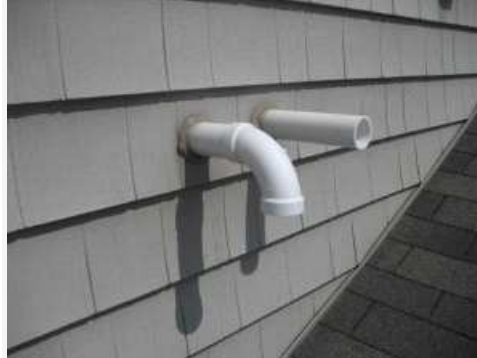
A mounting block was not installed where the furnace exhaust / air source pipes penetrate the siding. Mounting blocks are not required, but their presence is an indication of a good installation. Mounting blocks also permit the siding to contract and expand properly.

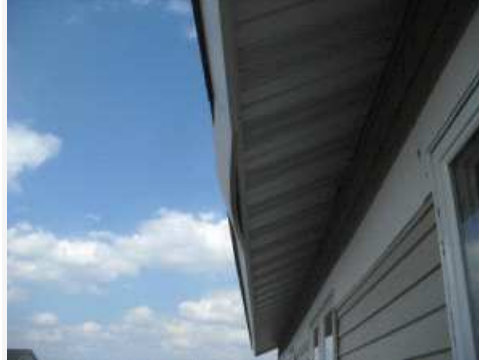
WOOD FASCIAS: One portion of the fascia board is badly warped. Replacement of this section is recommended.

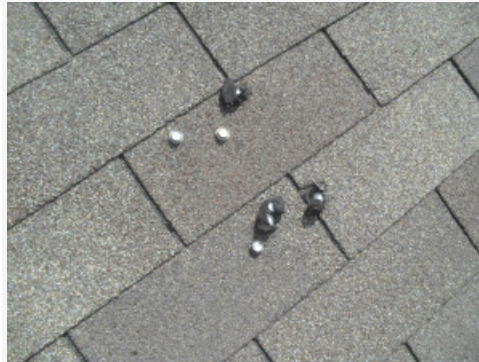
CONDITION: A satellite dish was removed from one location, but the screws / screw holes were not properly sealed.

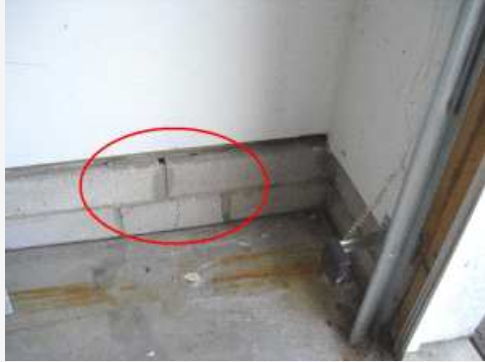
BLOCK: Some minor cracks exist at the front / right corner.

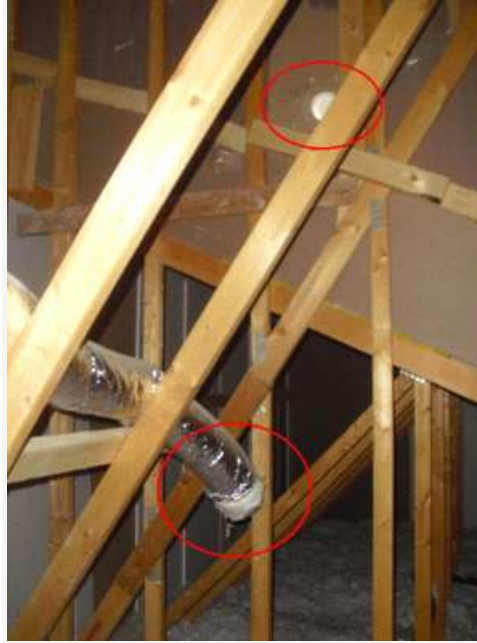
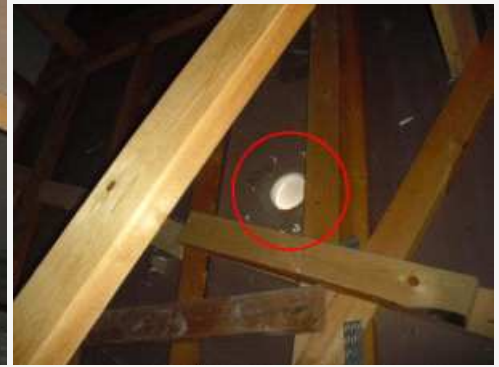
VENTILATION DESIGN:	No problems noted.
ATTIC VENTS:	No problems noted.
SOFFIT / EAVE VENTS:	No problems noted.
BATHROOM VENTS:	The master bathroom's vent is disconnected from its wall penetration. Repair is needed.

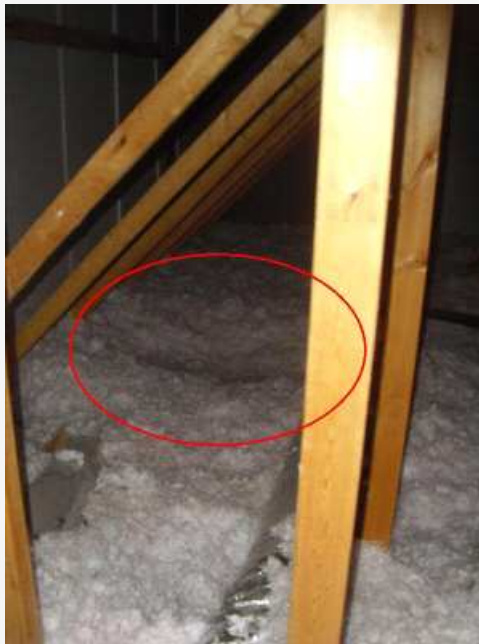
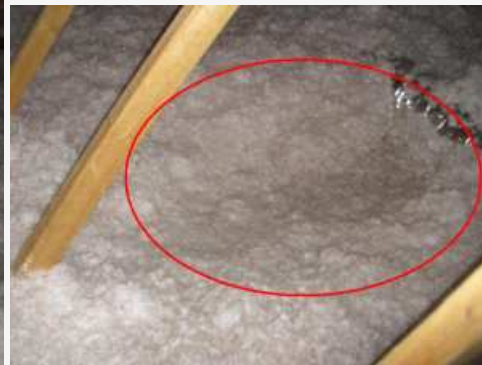
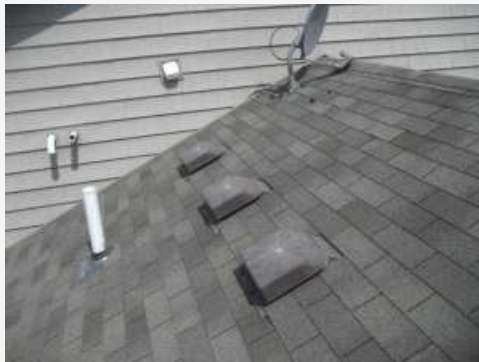
The insulation has been compacted below the lower level (living room) roof vents. In most cases, this is the result of snow that enters through the attic vents, which is not considered concerning. I suggest that you monitor the ceiling areas - below this location - for evidence of stains.

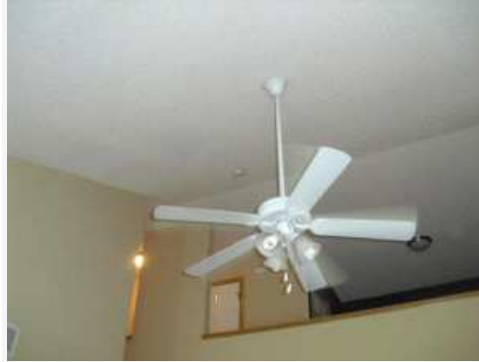
The fan in the main floor living room was improperly installed (is not balanced properly).

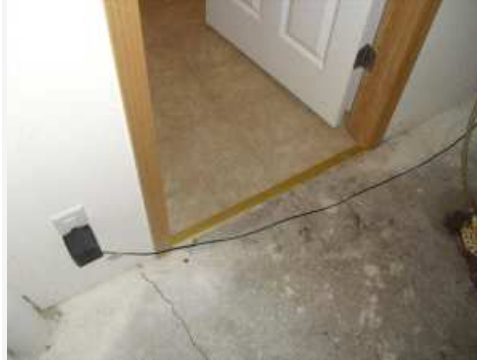
The cord for the water softener is a potential trip hazard in its current location.

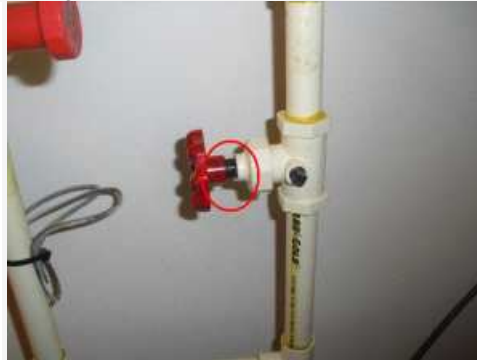
A small leak exists at the shut off valve.

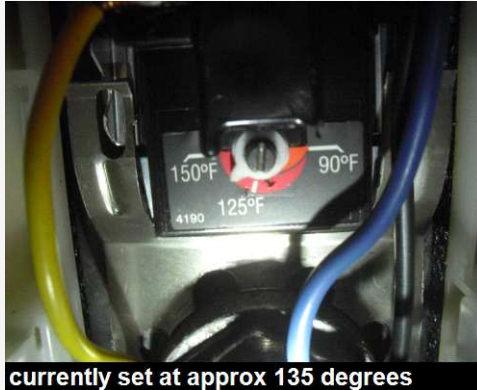
ELECTRIC ELEMENT: During the inspection, the hot water ran out in less than 5 minutes, which may indicate that the lower heating element has burned out. Further evaluation by a licensed plumber is recommended.

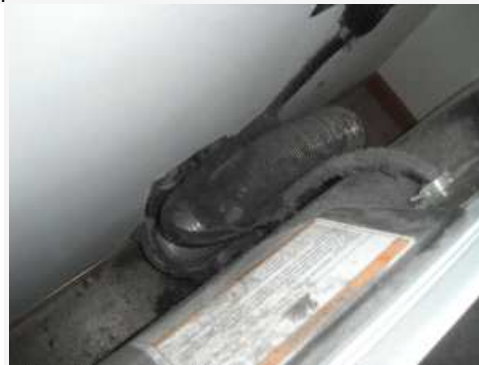
A buildup of lint exists behind the unit, which suggests that a gap exists in the exhaust duct. Repair is needed.

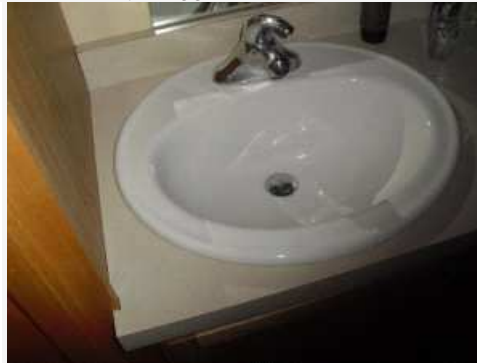
SINKS: One master bathroom sink is slow draining, which usually indicates that the drain plumbing / drain is partially clogged.

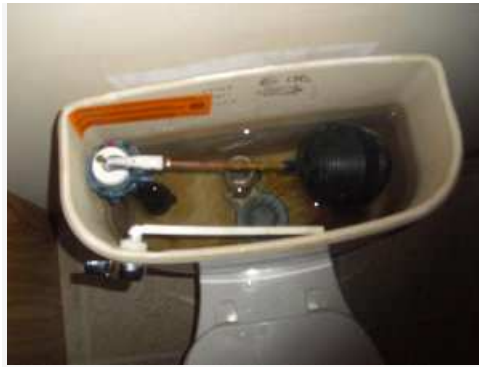
TOILET OPERATION: The toilet in the master bathroom runs continuously after flushing it. This can indicate any of the following: 1) Float arm not rising high enough 2) Water-filled float ball 3) Tank stopper not seating properly 4) Corroded flush valve seat 5) Cracked overflow tube 6) Inlet valve does not shut off.

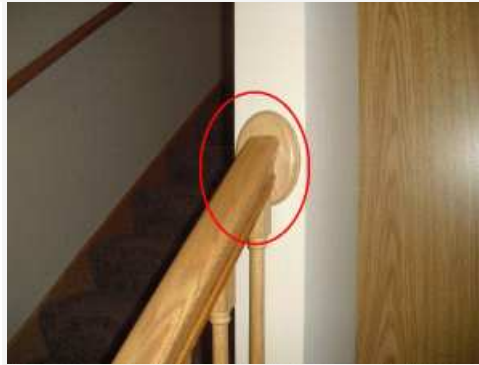
STAIR RAIL: One portion of the rail is not secured to the wall adequately.

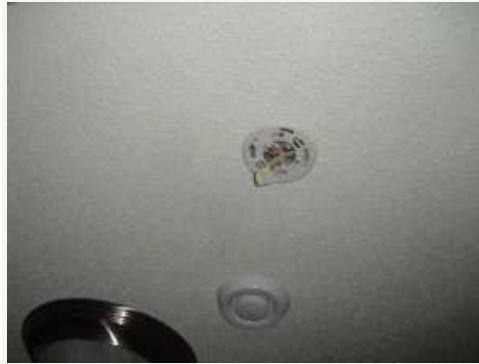
SMOKE DETECTOR  
CONDITION: The main floor detector has been removed from its base.
