## REMAINING INTERIOR PORTIONS

Inspection Address: 456 Sample Dr, MN 55555  
Report: 9340 Inspection Date / Time: 9-9-2025,

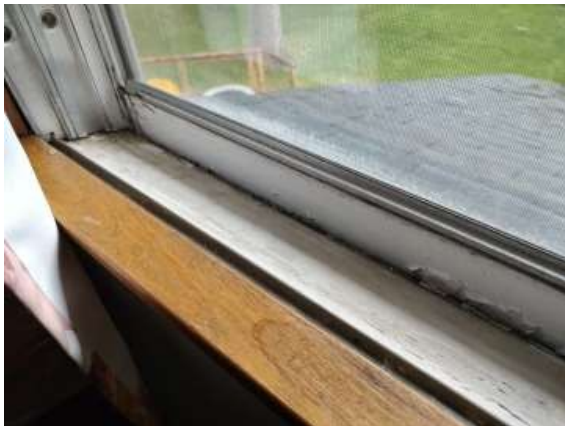
There are no weep holes at the base of the storm windows, which can allow moisture to collect along the sills. Paint is peeling at the bottom portions of most sashes - and this can lead to decay over time.

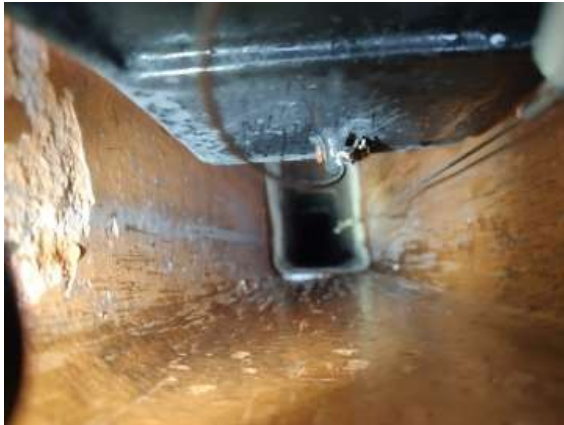
10% of one chimney flue interior was visible from the roof (first floor living room). None of the other flue interiors were viewed from the roof.

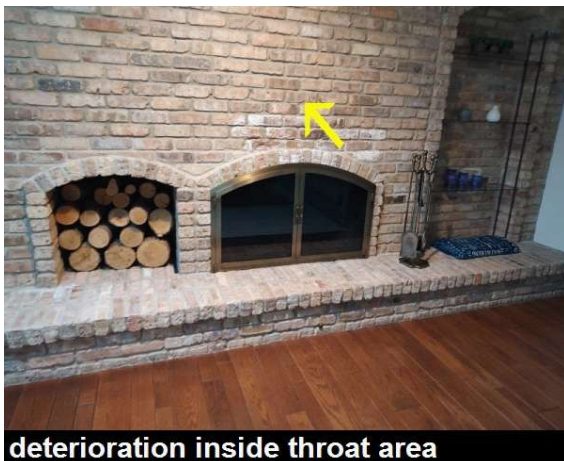
Deteriorated masonry exists inside the throat area (above the firebox - first floor living room). Repairs will be needed if you plan to use this fireplace for wood burning.

**deterioration inside throat area**

Further evaluation by a specialist is needed before you use any of the fireplaces. A specialist can determine whether any of the fireplaces are safe for use.

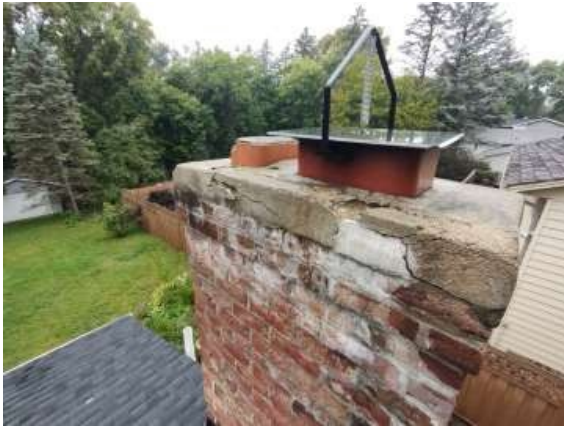
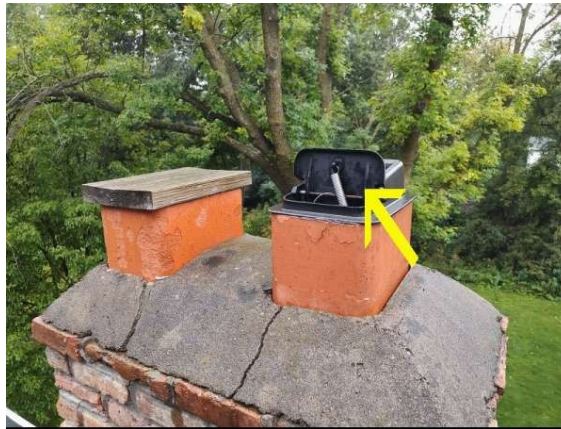
Note: One of the dampers is damaged and is no longer operational (first floor living room fireplace). This damper is stuck in the open position, which allows a pathway for pests to enter. Complete removal of this damper is recommended (cover should be replaced - and a standard cover could be used).

**damper damaged - does not operate**

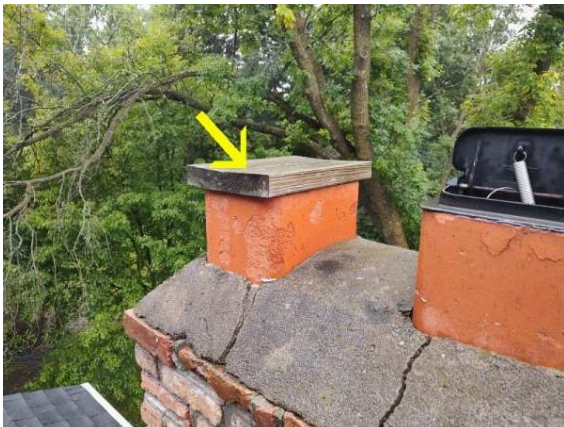
**no permanent cover**

Spark arrestors / cages should be installed at these openings to help keep sparks in and animals out.

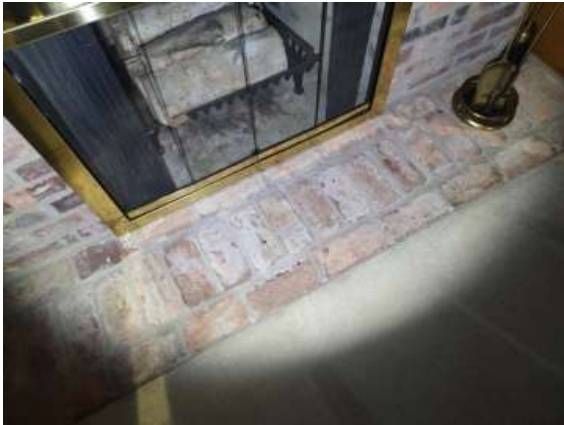
The hearth extensions extend less than 16" in front of the fireplace openings.
