Inspection Address: 123 Sample Blvd NE, MN 55555
Report: 9356 Inspection Date / Time: 9-29-2025,

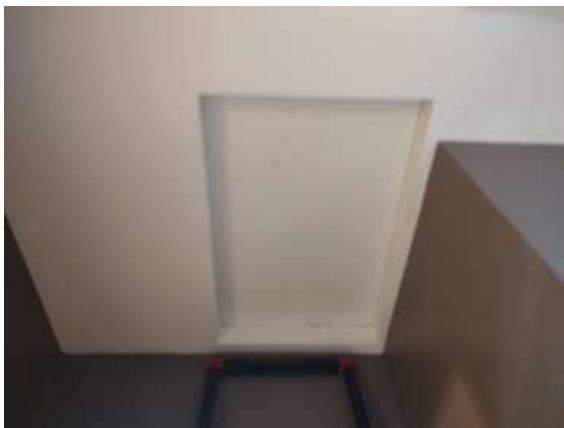
The hatch cover does not seal the opening properly (small gaps exist at the perimeter). This allows heat loss into the attic space to occur.

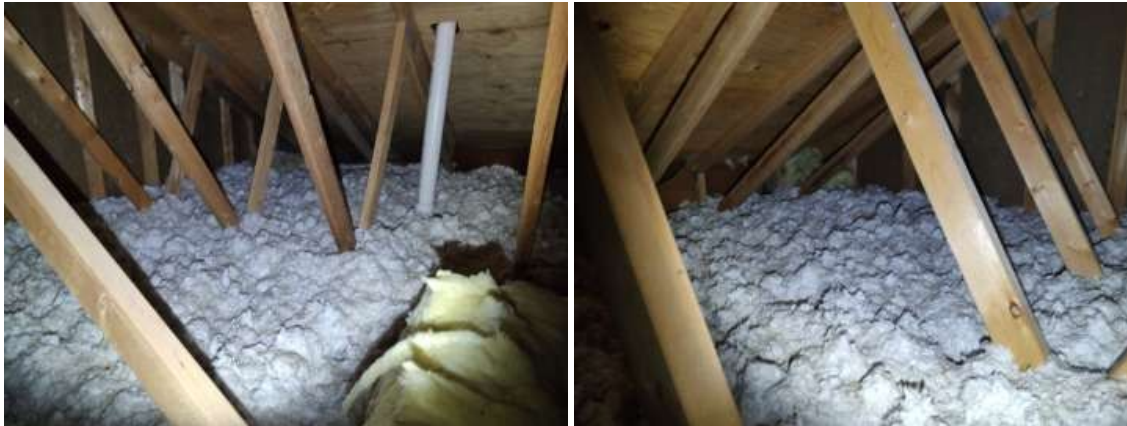
Approximately 12 inches of insulation was installed in the attic, but the depth has been reduced significantly at many locations from rodent activity (mice). The depth is now approximately 8" at most accessible areas.

Tunnels in attic insulation (compacted insulation) allow more heat loss to occur, which decreases the energy efficiency of the home and also increase the potential for ice buildup on the roof during winter months. The installation of more insulation is recommended (14" is ideal; an R-value of 49 is the requirement for new construction in Minnesota).

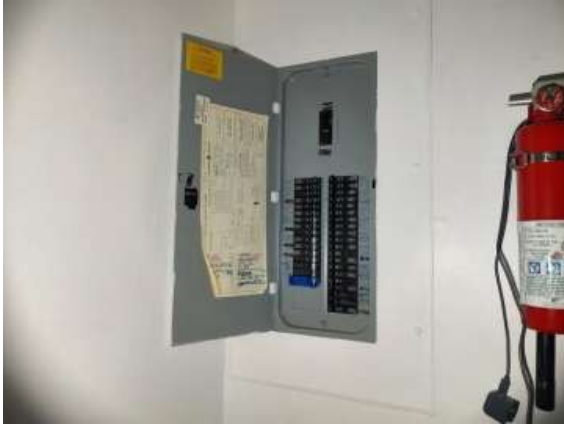
The panel cover is painted shut and could not be easily removed. The interior components were not inspected as a result.

If further evaluation is desired, contact a licensed electrician to open and inspect the panel box.

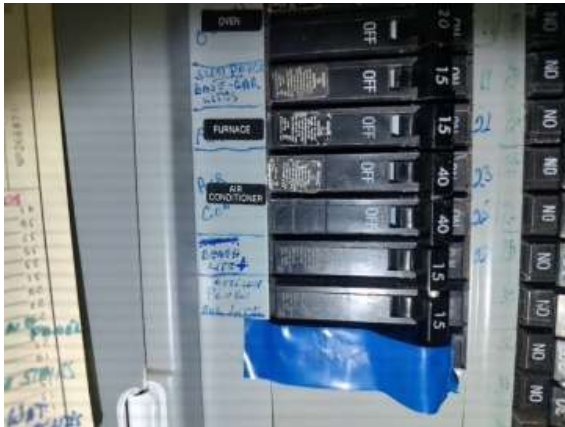
The air conditioner is over fused (has a larger breaker than it should, according to the manufacturer specs on the data plate). In this case, a 40-amp breaker is in use, but the data plate indicates that the maximum allowed circuit breaker is 30 amps. Over-fusing can result in premature damage to the compressor.

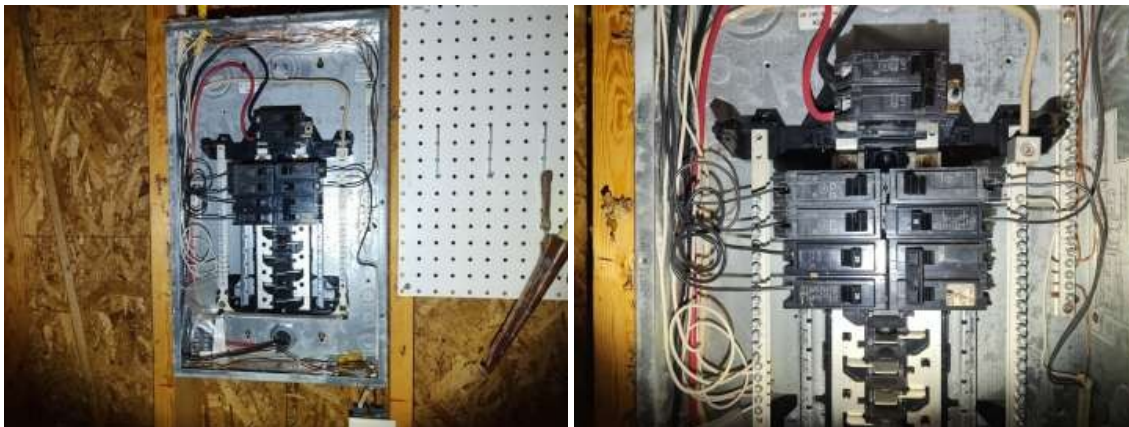
A sub panel was added to the system after the house was built. However, there is no sticker inside the panel box that would indicate that the wiring was approved by the City Inspector. No obvious concerns were identified during the inspection.

I suggest that you ask the sellers for all paper work associated with this upgrade.

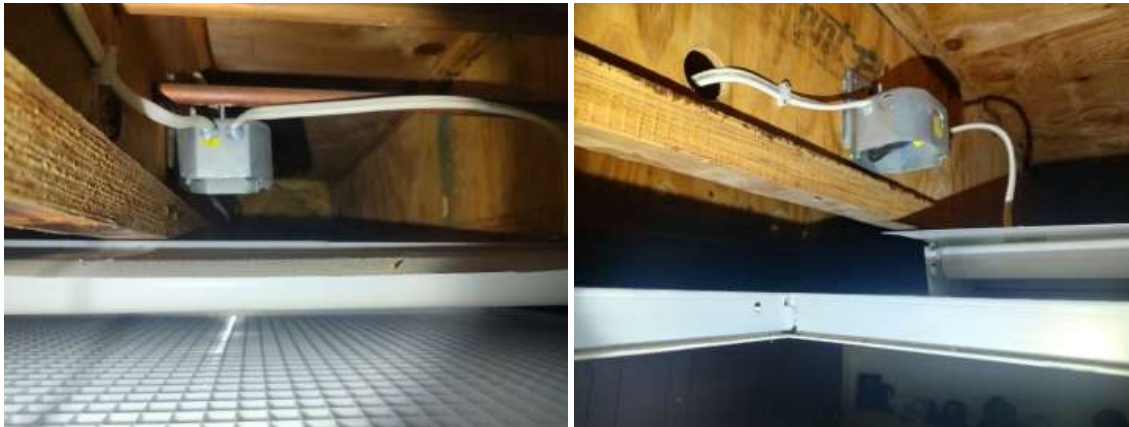
Some junction boxes are missing covers (behind ceiling panels). Tight fitting covers are required so that sparks / fire cannot spread to combustibles.

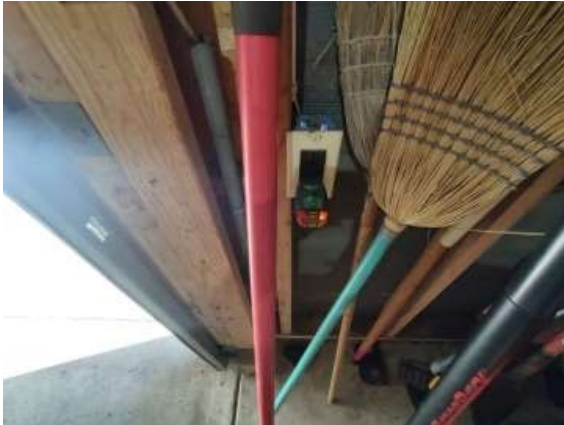
An open neutral was detected at one receptacle (outlet in tool shed - below the porch).

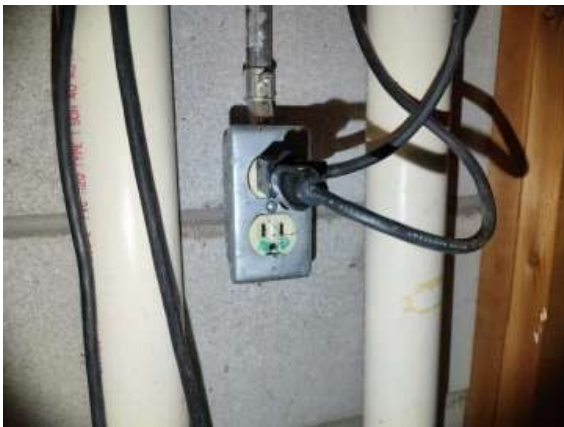
One receptacle for the drain plumbing sewage ejection pit is broken.

Some basement receptacles are loose.
