Inspection Address: 123 Sample Blvd NE, MN 55555
Report: 9356 Inspection Date / Time: 9-29-2025,

HEATING & COOLING SYSTEMS

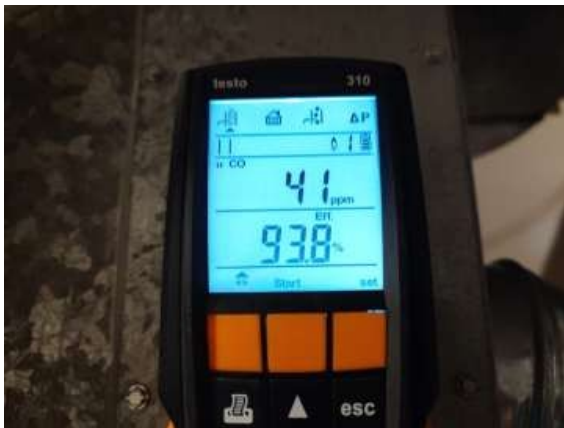
UNDILUTED CARBON MONOXIDE (uCO):

41 ppm
(Normal range is 14-45 ppm)

ELEVATED CO:

The CO levels inside the exhaust flue were slightly elevated at the time of the inspection (over 40 ppm).

While elevated CO can indicate a problem with the heat exchanger, in most cases, a simple adjustment / tune-up can correct this condition. A professional tune-up and safety check is recommended.

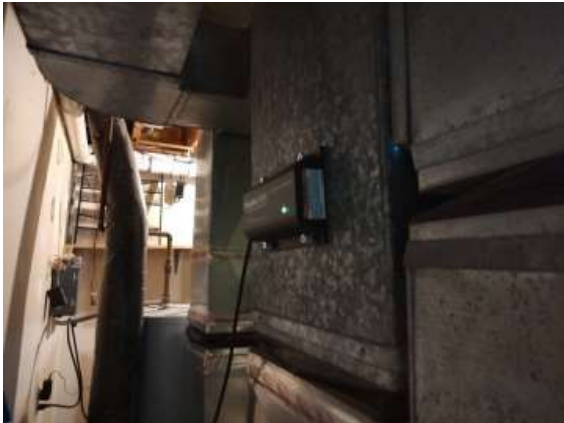
An air purification system was added to the supply plenum, but the effectiveness of this device was not determined. Note: This device has an ultraviolet light, which can harm eyes or skin. This device should be off when servicing the unit.

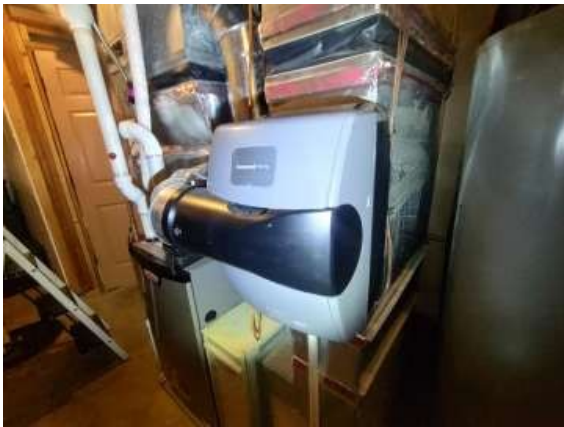
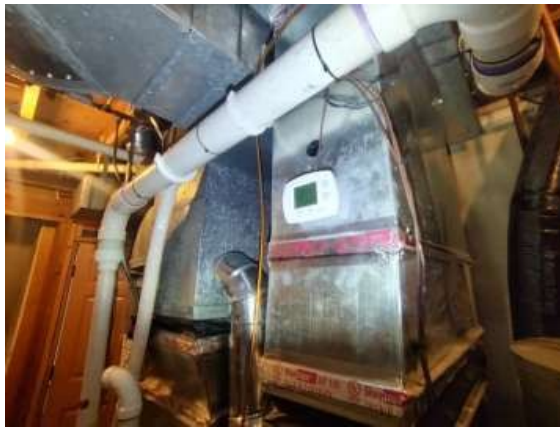
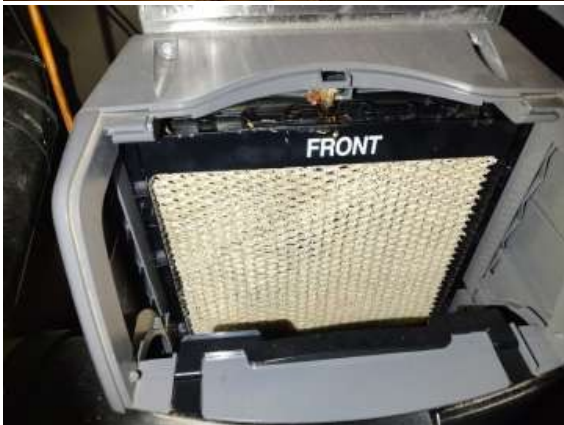
HUMIDIFIER:

Excessive hard water deposits exist on the water panel. Replacement of the water panel is needed.

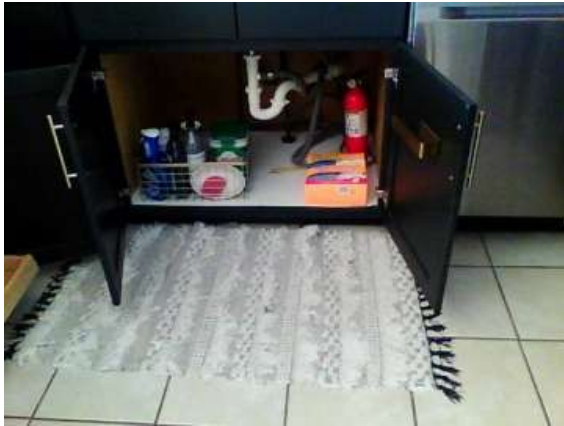
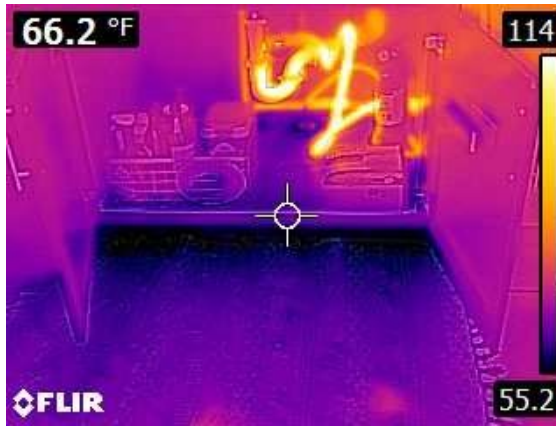
One kitchen register opening has been covered by the cabinet (below sink area - see photo).

The two first floor living room registers have been covered / sealed (reason for this was not determined).

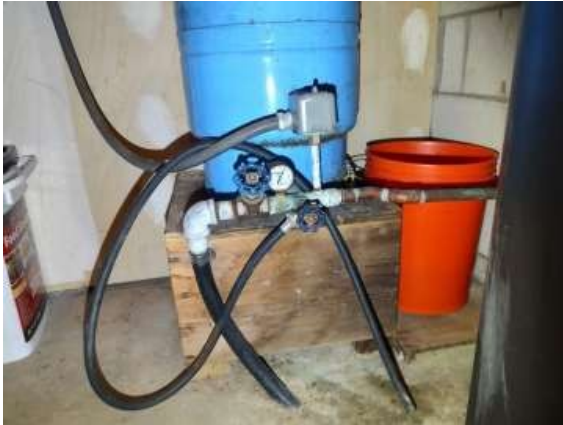
The pressure gauge does not work, which prevented a complete evaluation of the system (proper operating pumps usually cycle between 40 psi and 60 psi).

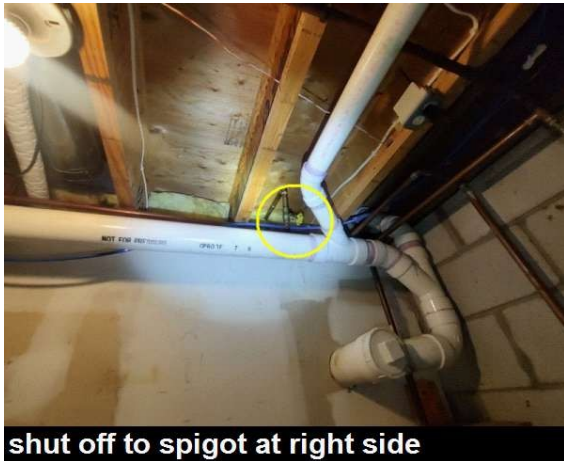
shut off to spigot at right side
