Inspection Address: 123 Sample Blvd NE, MN 55555  
Report: 9356 Inspection Date / Time: 9-29-2025,

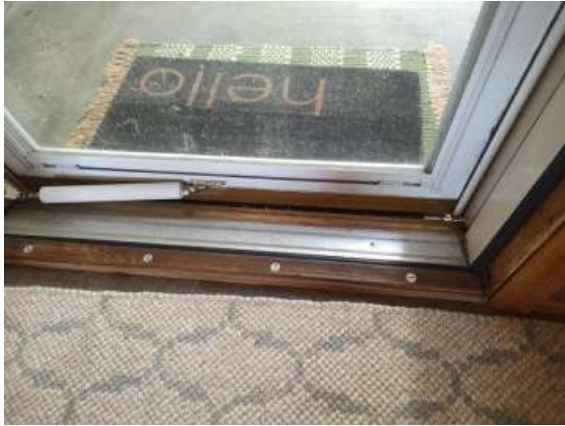
A large gap exist at the base of the front storm door. Improvements to the weather stripping are needed.

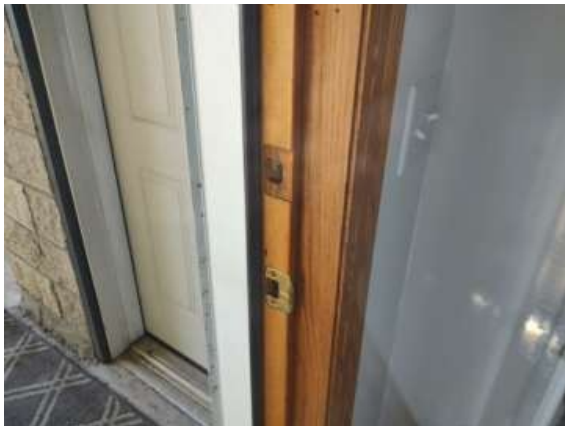
There is no strike plate installed on the door jam (basement door).

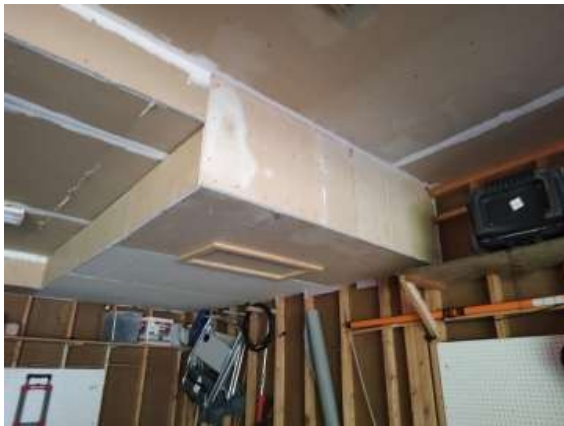
The house roof drains across the long, unconditioned portion of the garage roof. This cold zone may allow draining water to re-freeze above the garage. If this ice buildup becomes excessive, ice dams can occur, which can result in leakage. Moisture stains exist on the garage ceiling, which indicates that leakage has occurred at one time (possibly from past ice dam issues), and that it could recur.

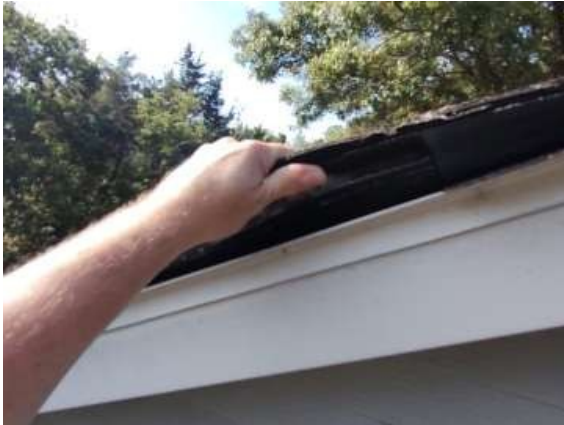
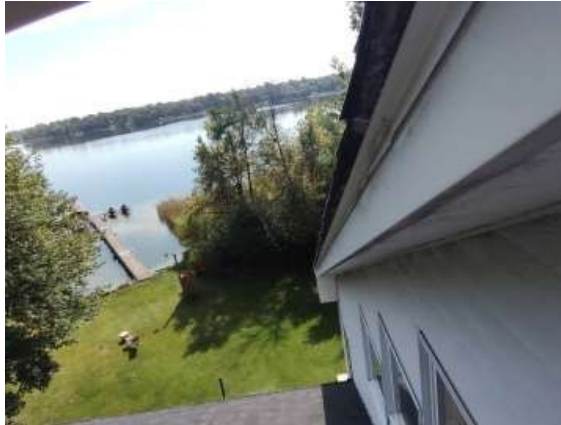
Some of the shingles were inadequately sealed / fastened - at the rake ends of the roof.

The shingles also extend too far beyond the roof line at some of these locations.

The general consensus for how far roof shingles should hang over the drip edge is 1/4 inch to 3/4 inch. This is for optimal water flow, protection of the fascia and roof decking, and wind resistance.

Too much overhang (1 inch or more) can make the shingles more susceptible to wind lift.

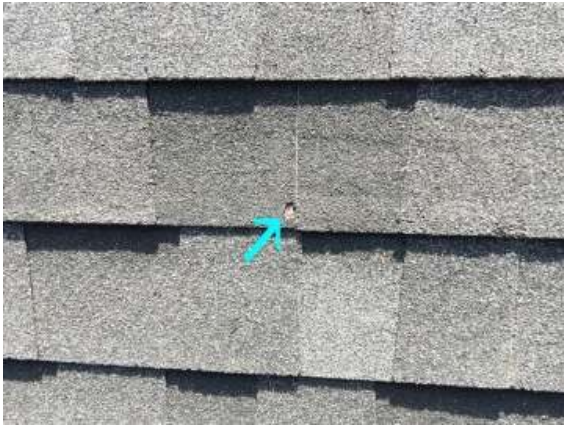
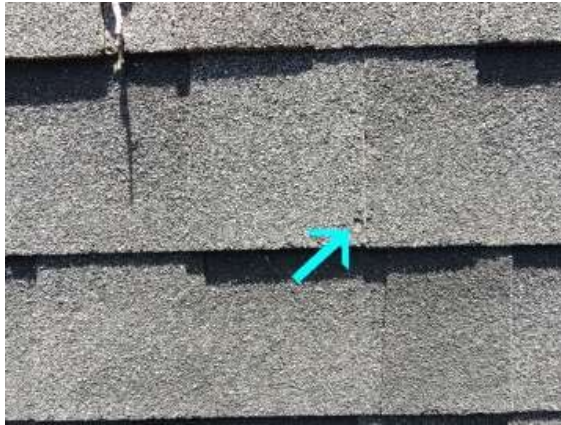
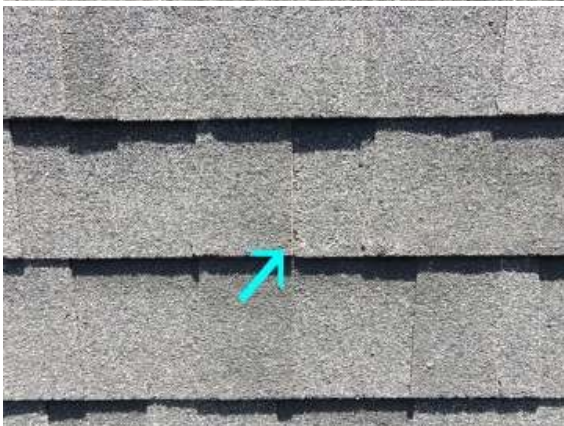
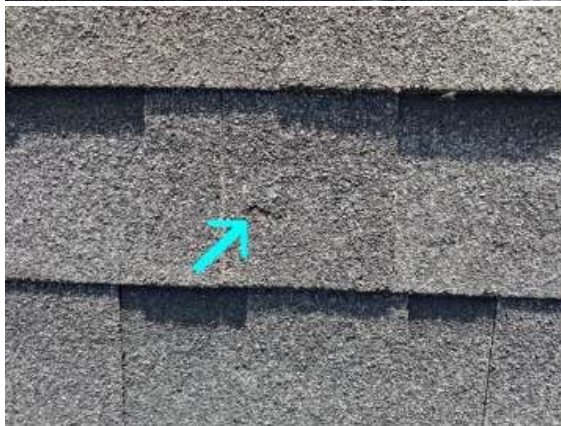
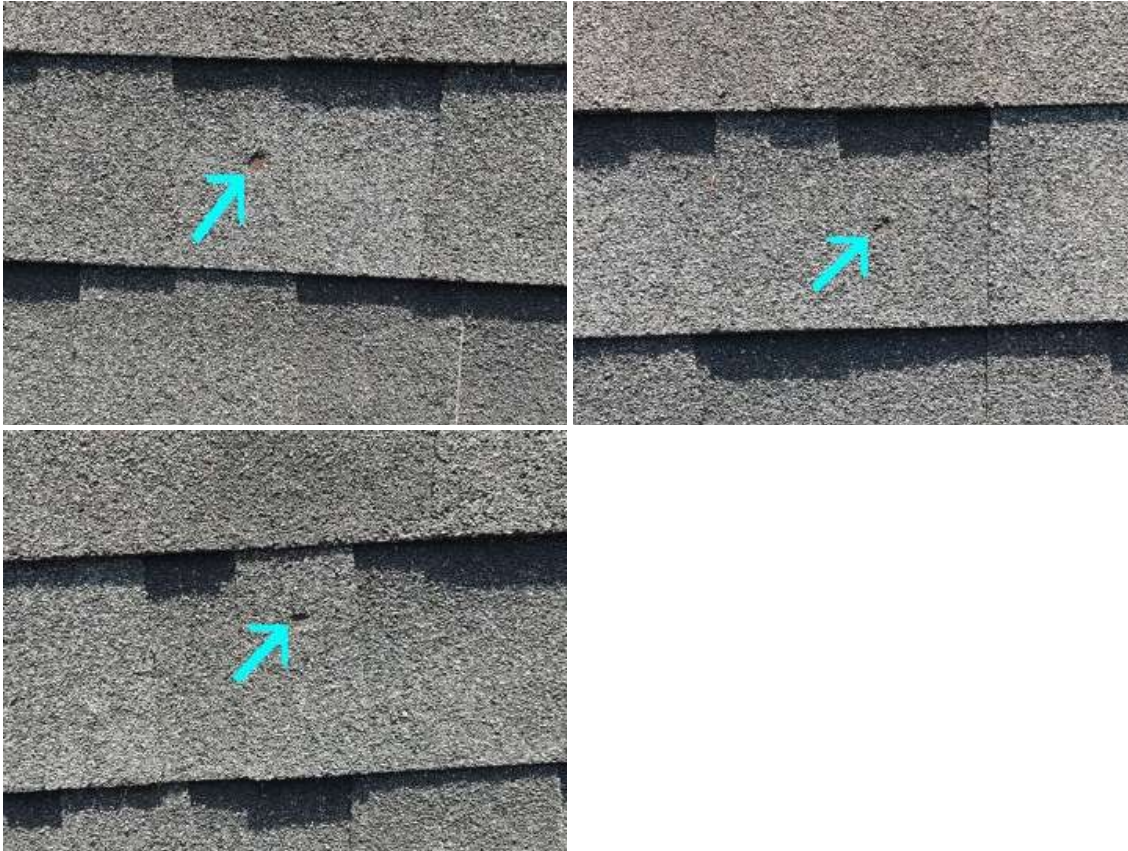
Small diameter pitting exists at some isolated shingles (see photos). Pitting like this is often caused by hail, but the exact source was not determined during the inspection.

This deterioration is not concerning, but it will result in a reduced lifespan for these shingles. I suggest that you ask the seller for more information. Has the roof ever been inspected by an insurance adjuster?

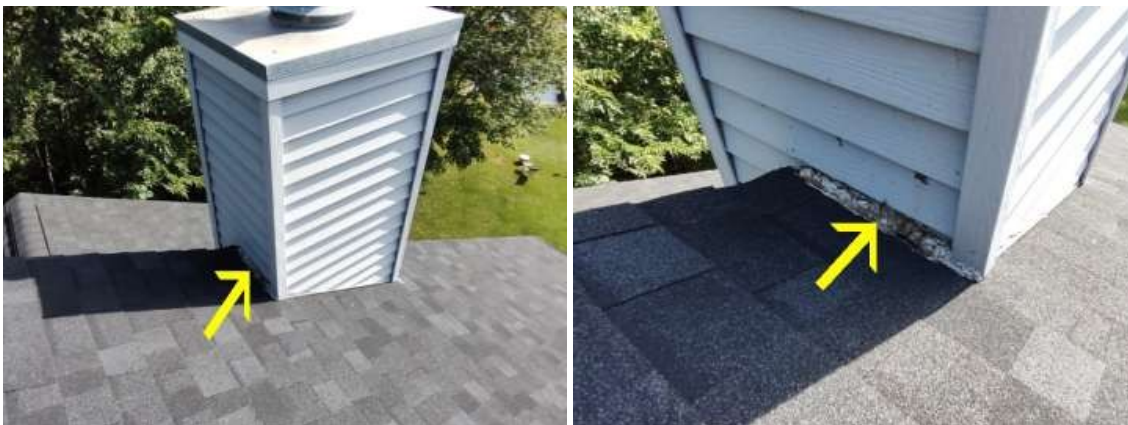
There is no diverter at the base of the chimney chase (see photos). This allows rain water to drain against the siding - and the gap at this location has allowed water to drain behind the siding. Some amount of concealed damage to the wall sheathing - below this location - has likely occurred.

Stains do exist on portions of the roof sheathing below this area (visible from inside attic space).

Improvements to the flashing are needed - and the gaps in the siding must also be sealed.

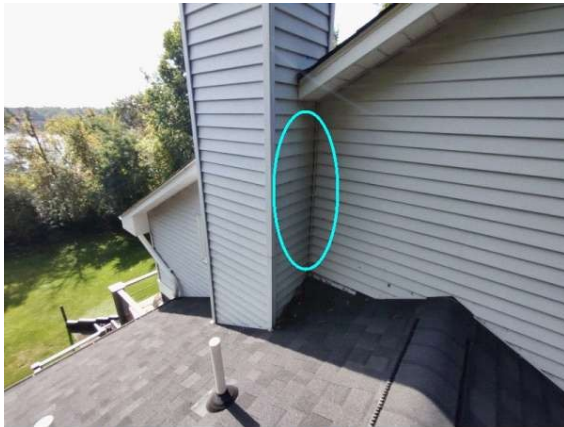
**potential for concealed damage**

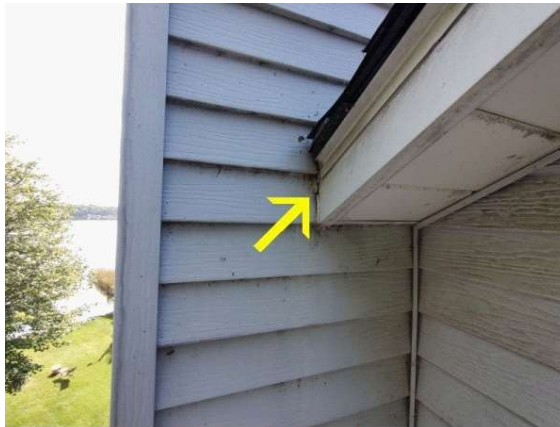
**water has drained through gap**

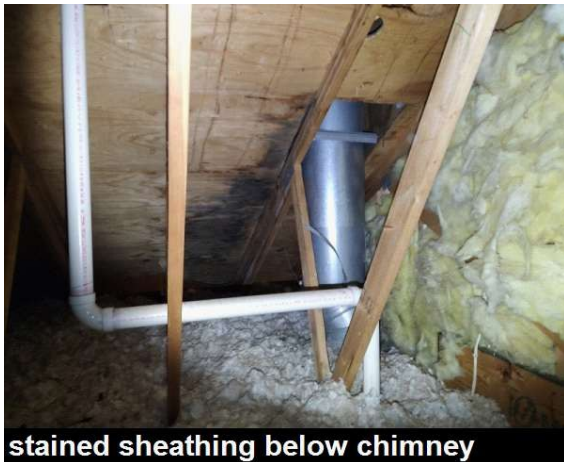
**stained sheathing below chimney**

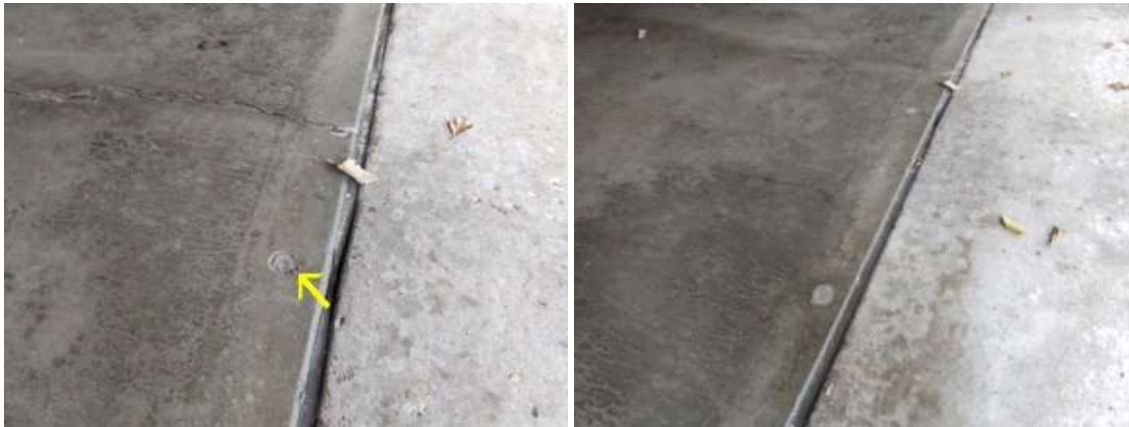
The patched holes in the floor slab indicate that the floor has been mud-jacked at one time. This indicates that the slab had settled, but was raised. Note: It is possible for future settlement to recur.

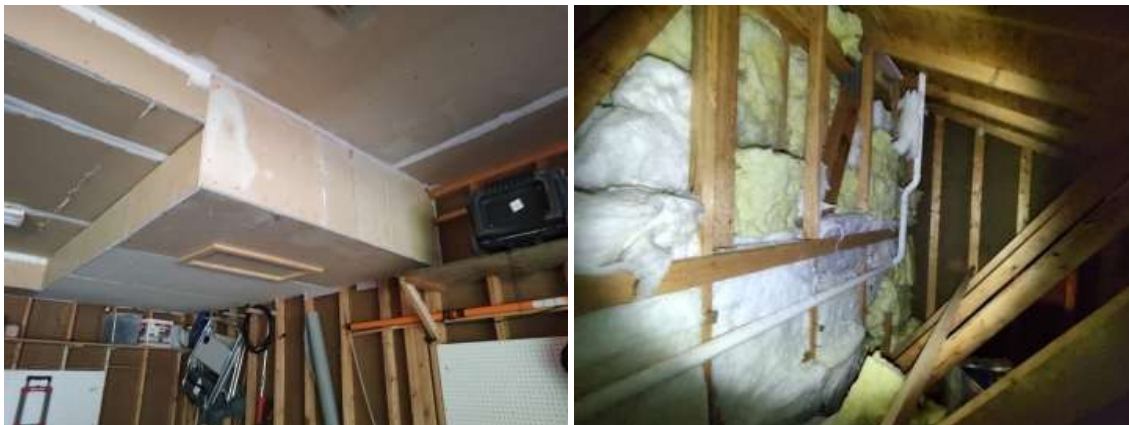
There is no tape / mud at the drywall ceiling joints - and large gaps exist at some locations.

According to the fire code, all walls that connect to living portions of the home must be completely covered with a fire-rated material (drywall) - and most cities also require the joints to be sealed with tape & mud.

Large gaps also exist at the top of the back garage wall (see photos). Gaps can allow car exhaust gases / carbon monoxide to enter the home. Gaps also allow an easy pathway for rodents to enter the attic spaces - and potentially the home.

Several dead mice were found inside the garage attic space.

The exposed insulation on the vertical walls (inside the garage attic) is damaged at some locations - which was caused by rodents.

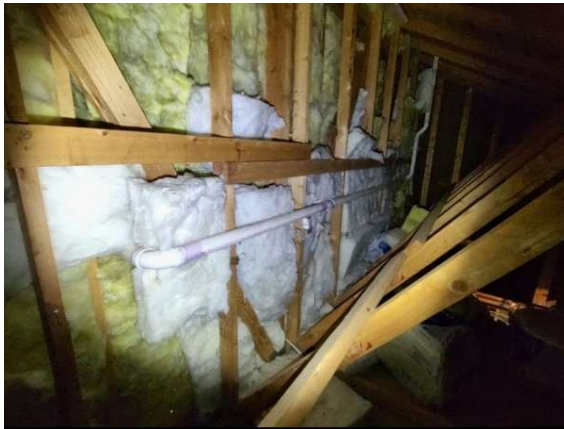
The vent plumbing from the master bathroom is also exposed inside the garage attic. Ideally, these pipes would be enclosed / wrapped in insulation. This can help prevent frost buildup inside the pipes, which can cause clogging. Gaps also exist where these pipes penetrate the drywall, which create potential entrance points for rodents.

**exposed vent plumbing**

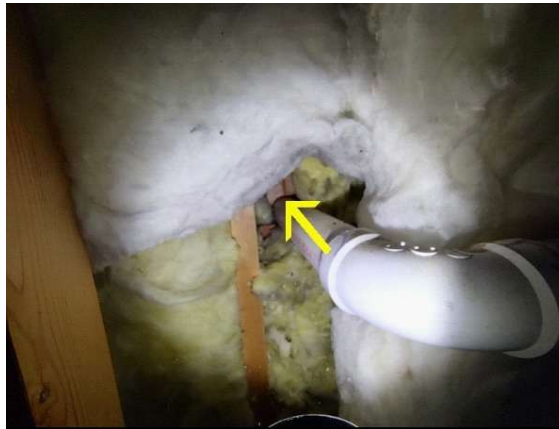
**gaps where pipes penetrate**

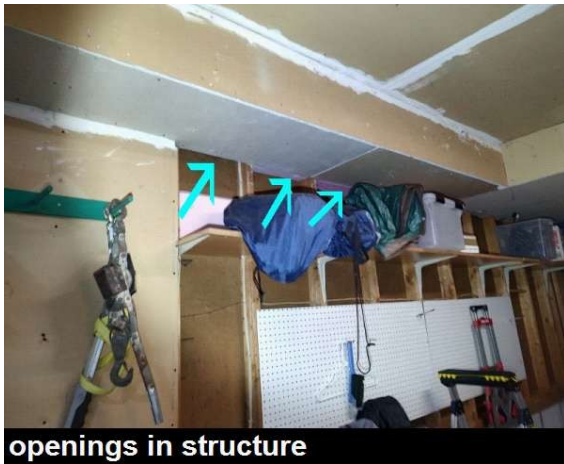
**openings in structure**

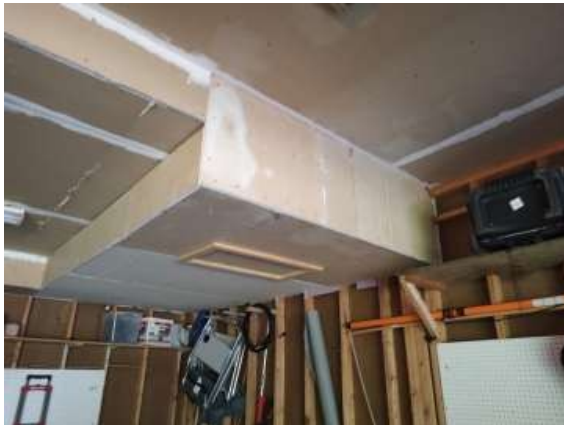
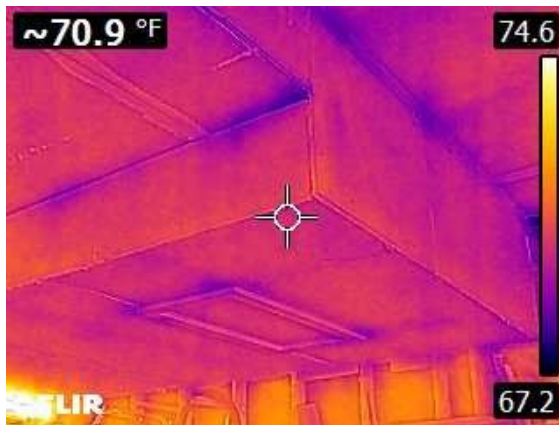
Water stains exist on a portion of the garage ceiling - below the bathroom area. This indicates that leakage has occurred at one time. No signs of active wetness were detected at the time of the inspection, but I suggest that you ask the sellers what occurred here.
