Inspection Address: 456 Sample Dr, MN 55555
Report: 9340 Inspection Date / Time: 9-9-2025,

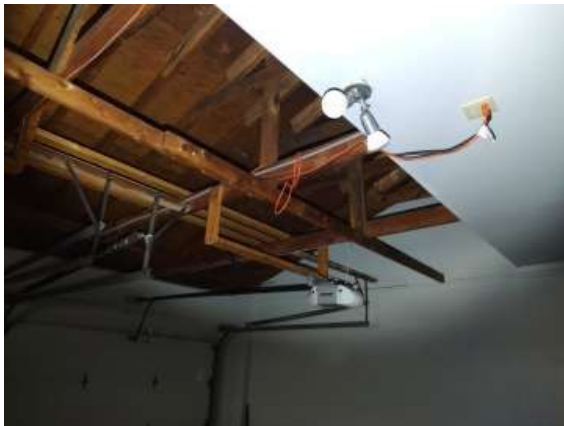
Extension cords are used for the automatic openers, which is improper. Extension cords can overheat if used as a permanent power source, which creates a potential fire hazard. Hard-wired outlets should be installed near the openers - so that the manufacturer's cords can plug directly into the outlets.

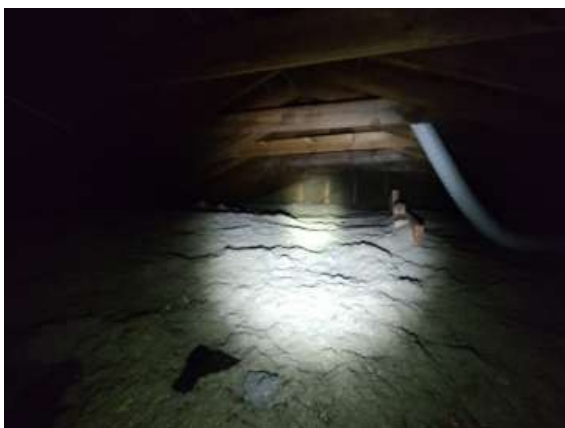
8-10 inches of insulation exist in the attic space. More insulation is recommended (14" is ideal; an R-value of 49 is the requirement for new construction in Minnesota).

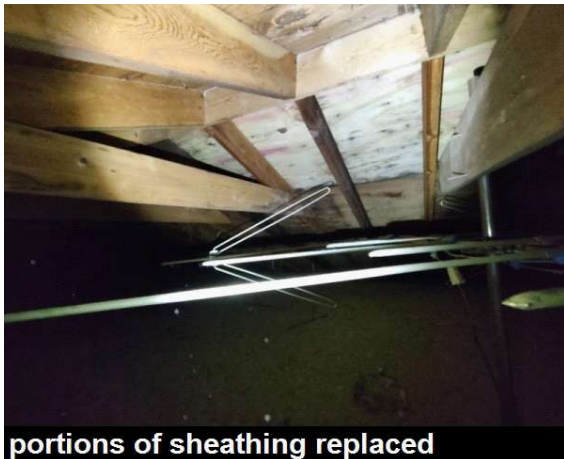
Note: Some portions of the sheathing have been replaced - and this likely occurred during the last re-roofing. It is unknown if the existing delaminated portions were present when the last roof was installed.

portions of sheathing replaced

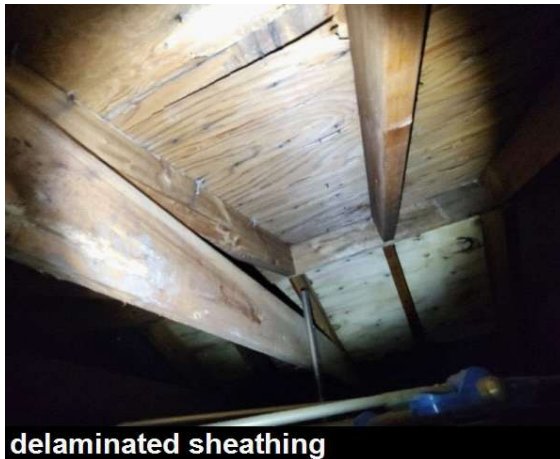
Portions of the sheathing have delaminated / decayed.

Decay is most commonly caused by condensation accumulation inside the attic space - which is the result of heat loss into the attic space. This causes frost buildup on the structure during winter months.

The primary concern with delaminated sheathing is that the shingle fasteners are not as secure. This creates potential blow-off concerns during high wind storms.

delaminated sheathing

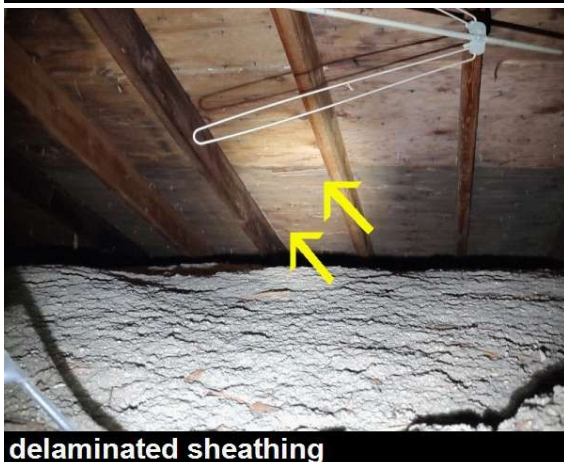
delaminated sheathing

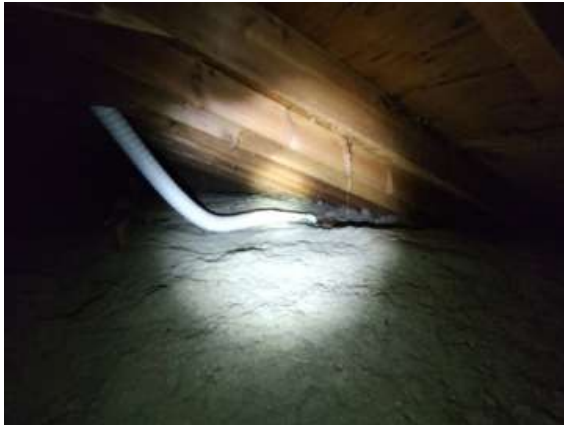
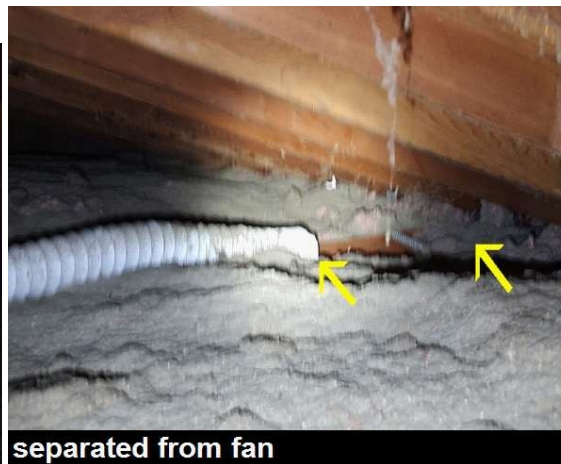
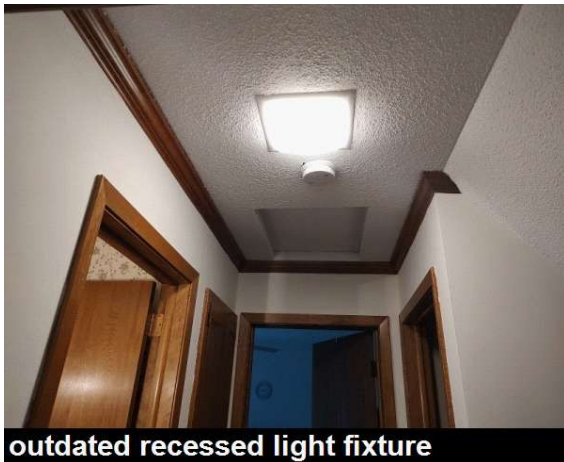
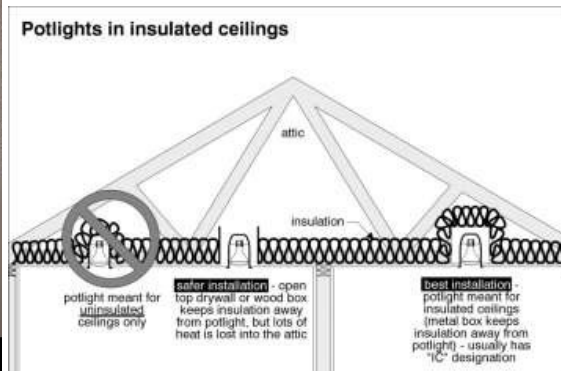
The bathroom vent has separated from the fan (above master bathroom) - and is venting into the attic space, rather than at the house exterior. This allows large amounts of warm, moisture-filled air to collect inside the attic space, which results in frost / condensation - and can also lead to mold growth. This will also cause ice buildup on the roof in winter months. Repair is needed.

Some outdated recessed lighting fixtures exist in the home (penetrate the attic level ceiling). Recessed fixtures that were manufactured prior to 1993 generally provide a major route for air exfiltration, which increases heating bills, and also increases the risk of condensation in the attic space.

Additionally, these fixtures are rarely rated for insulation contact, which can create potential overheating hazards. Therefore, upgrading the fixtures to modern, insulated canisters (or flush mounted fixtures) is recommended.
