Inspection Address: 456 Sample Dr, MN 55555
Report: 9340 Inspection Date / Time: 9-9-2025,

EXTERIOR WINDOWS:

ROOF

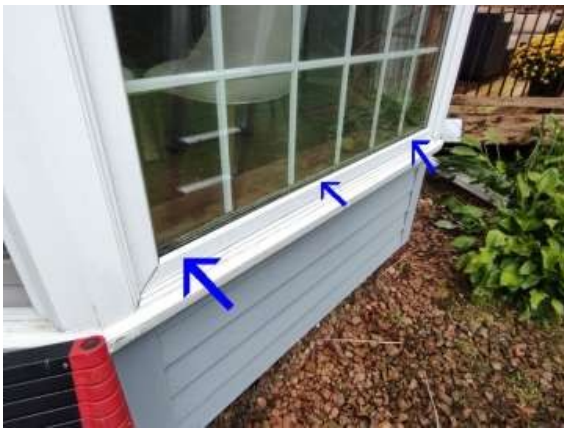
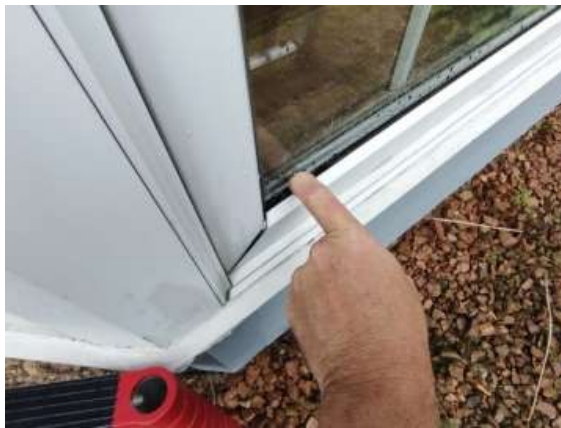
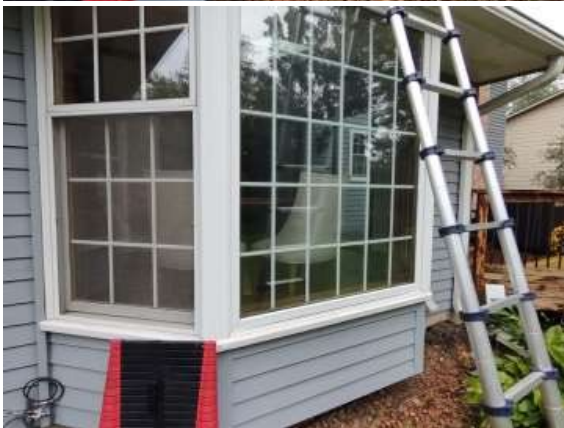
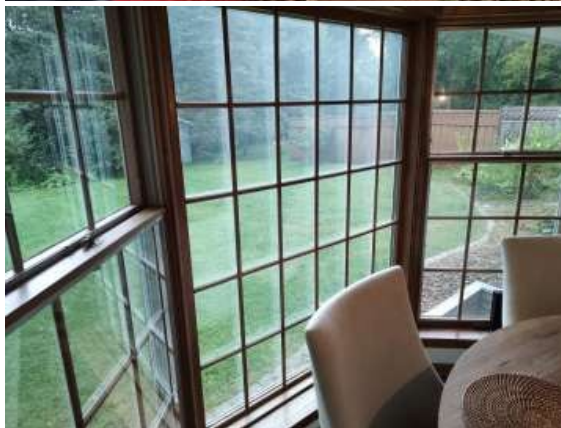
The bottom sash for one dining room window has completely decayed - and the window seal has also failed (fog between panes). Complete replacement of this window is needed.

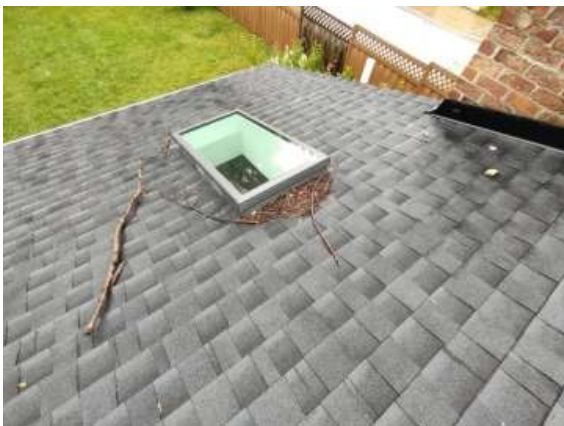
Debris exists at the back side of a skylight, which increases the chance for moisture to back up beneath the shingles. This should be periodically removed - particularly before winter.

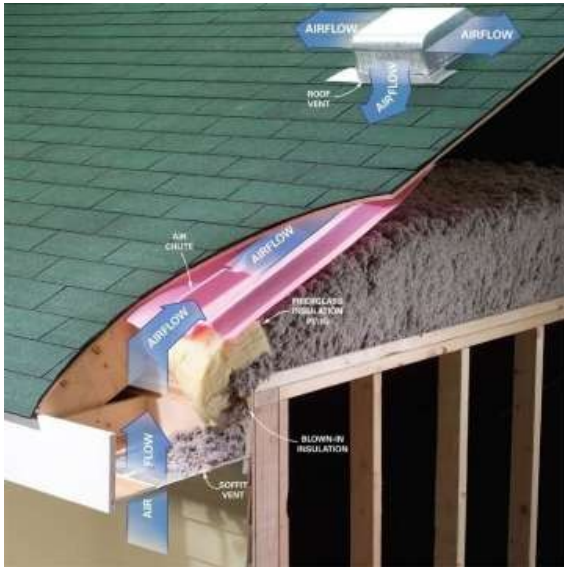
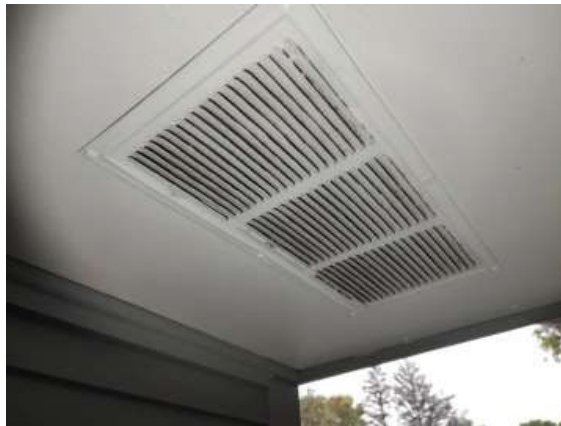
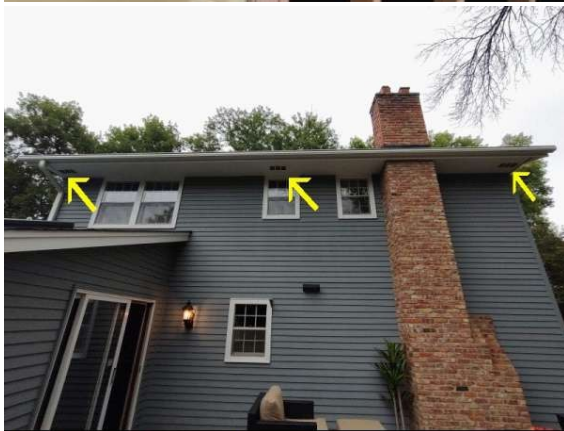
An inadequate number of soffit vents were installed - and the existing vents are partially blocked with debris.

inadequate number of vents

Soffit vents are intended to pull air into the attic space through the eaves, which then pushes warm air from inside the attic up and out through the roof vents (at the roof ridge locations). This cyclical effect keeps the attic cooler, which helps prevent the formation of ice dams. New codes recommend soffit vents spaced every 6'.

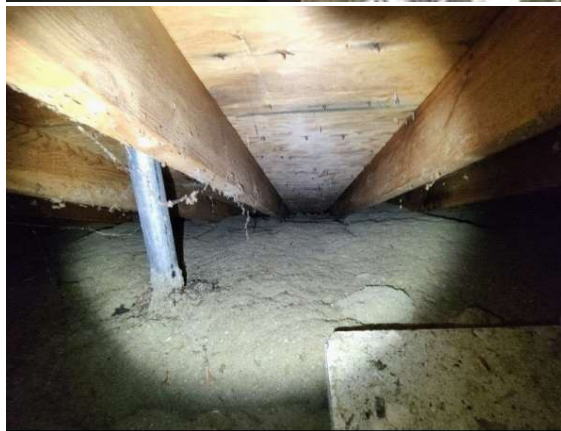
no baffles installed

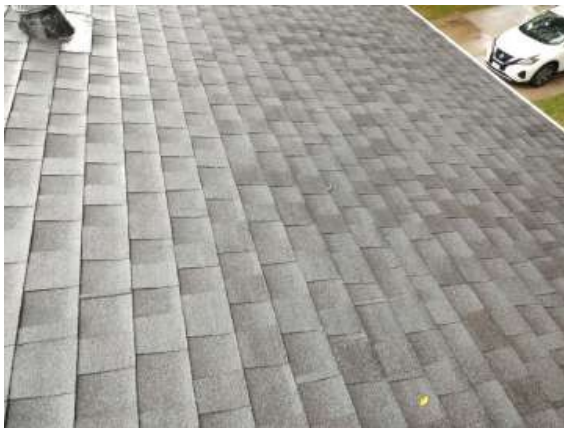
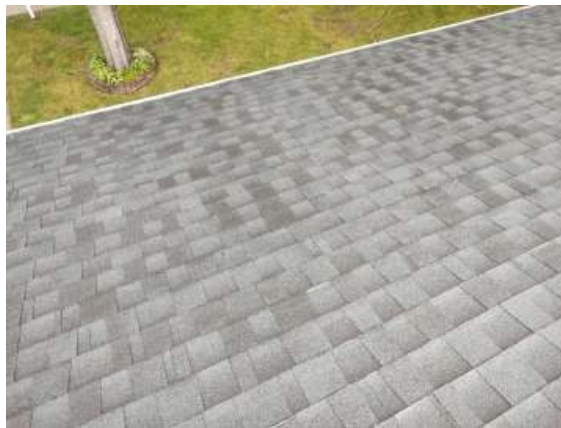
Portions of the roof decking are soft when walked on - which indicates that the plywood is decaying (see attic section for more details). Note: Shingle blow-off is more likely to occur when shingles are fastened to decayed roof sheathing. These areas should also be considered potentially hazardous for foot traffic.

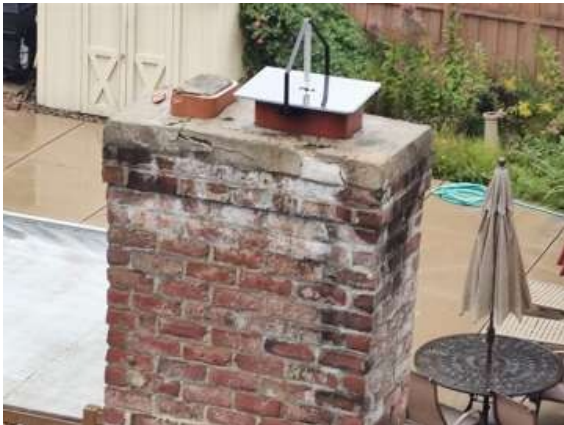
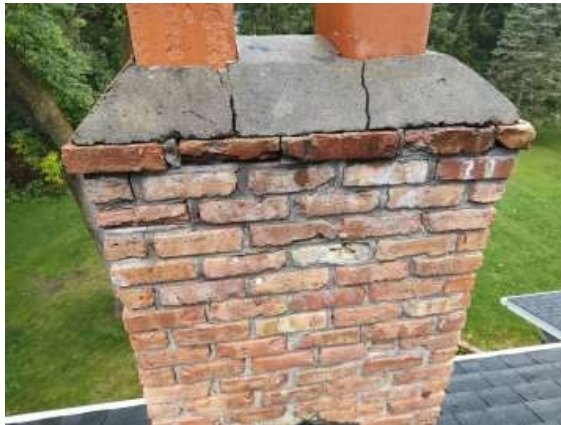
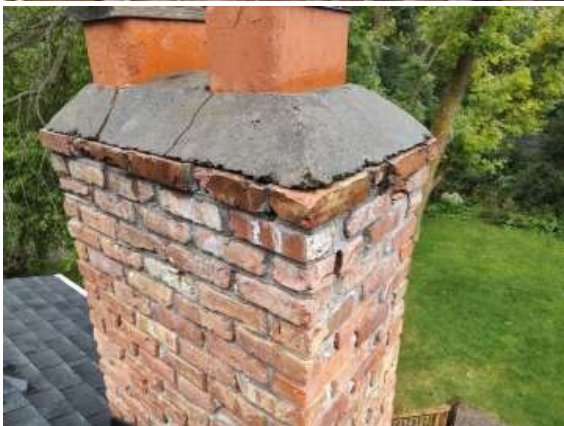
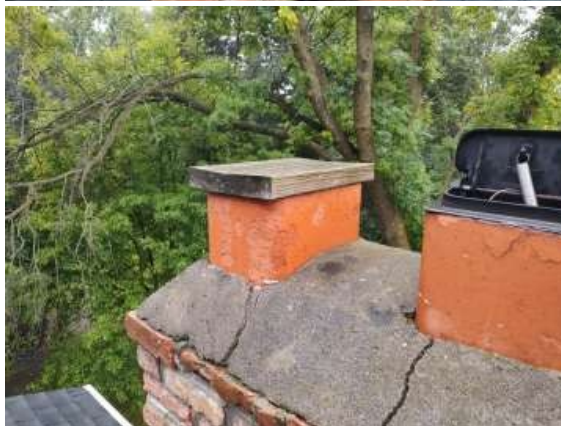
The mortar caps have cracked / deteriorated and are in need of repair, or replacement. Cracks in the mortar cap allow water to enter, which eventually causes the brick and mortar to deteriorate. In this case, portions of the masonry have deteriorated / spalled at the top portion of one chimney. Repairs are needed.

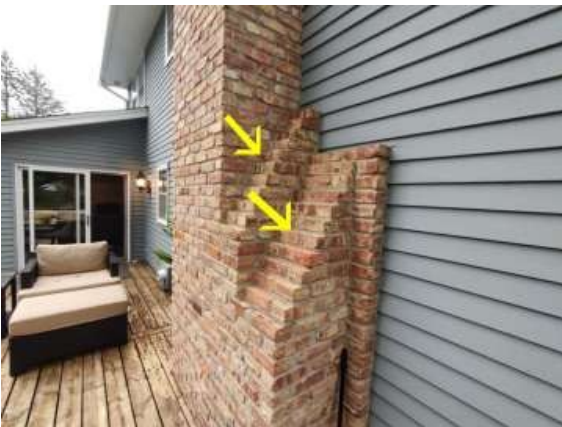
The stair-step portions of the brick - at the back side of the home - were not capped with mortar. Mortar should be applied to the top of the bricks to help prevent water from deteriorating the surfaces. The mortar should also be sloped so that water is shed away from the home.

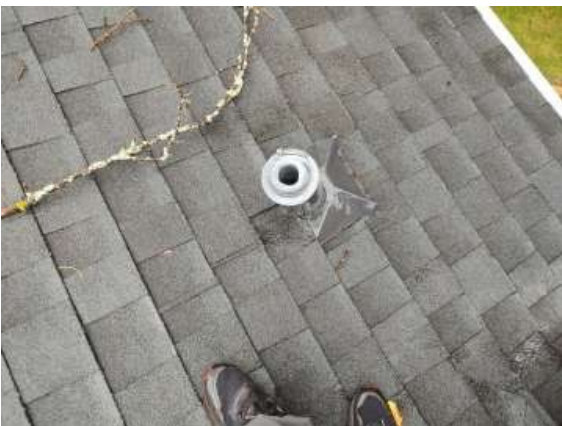
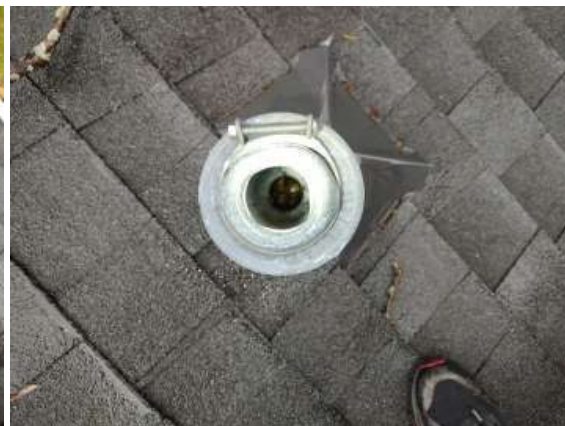
One of the plumbing vents is clogged with debris, which prevents sewer gases from venting properly (above master bathroom). The extent of the clog was not determined, but the debris should be cleared.
