Inspection Address: 456 Sample Dr, MN 55555
Report: 9340 Inspection Date / Time: 9-9-2025,

CLIENT, SITE & OTHER GENERAL INFORMATION

REPORT #: 9340.	TYPE OF INSPECTION: Pre-Purchase Home Inspection.	PROPERTY INSPECTED: 456 Sample Dr, MN 55555.	INSPECTION DATE: 9-9-2025.
CLIENT: Sample.	CLIENT E-MAIL: sample@sample.com .	BUYER'S AGENT: Sample.	PEOPLE PRESENT: Sample.

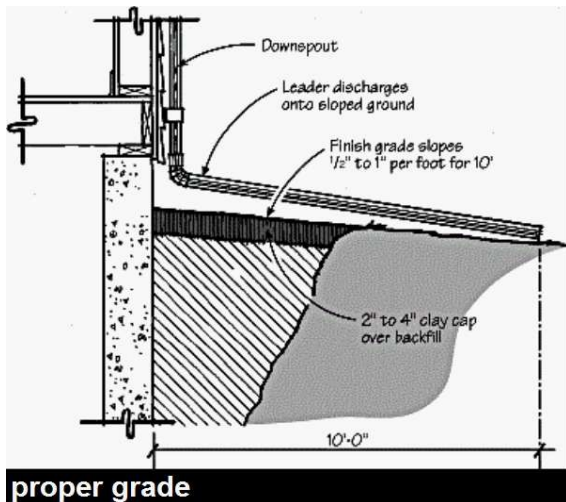
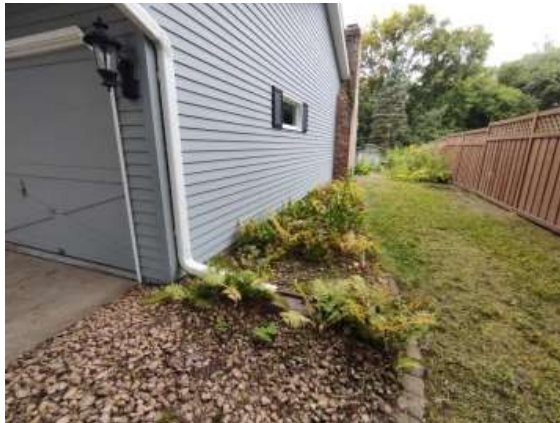
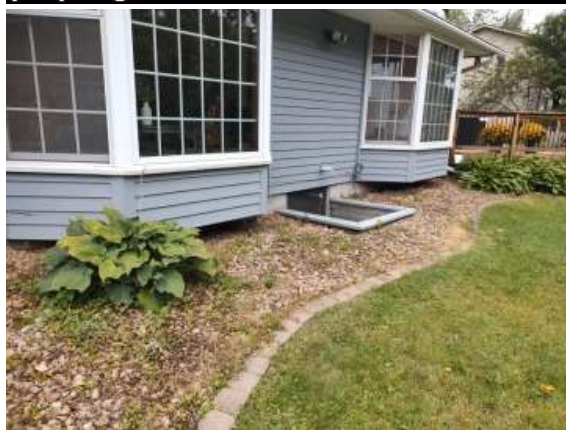
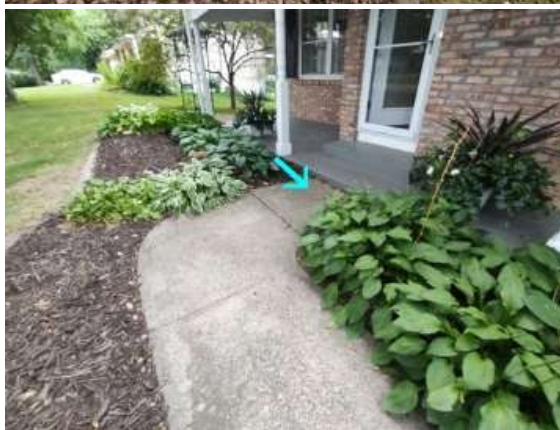
GRADING - FLAT / NEGATIVE SLOPE:

The grading - and portions of the paved surfaces (sidewalk / driveway) - are flat, or are negatively sloped toward the home (portions of front, right and back sides). A positive slope - for a minimum of 10', is recommended. Flat or negatively sloped grading allows rain water to accumulate near the foundation walls, which increases the chance for water to leak into the home. Accumulating water can also erode the soil, or foundation over time - and can cause settlement of the foundation.

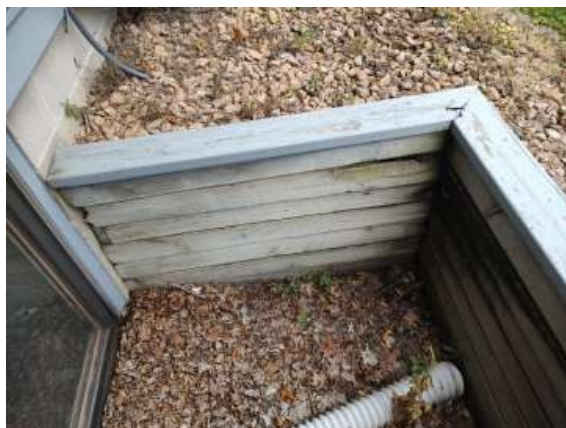
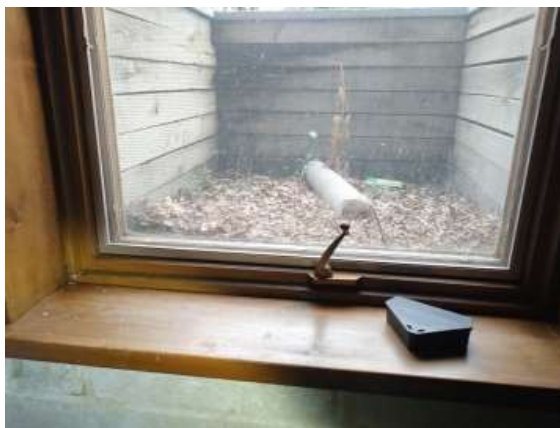
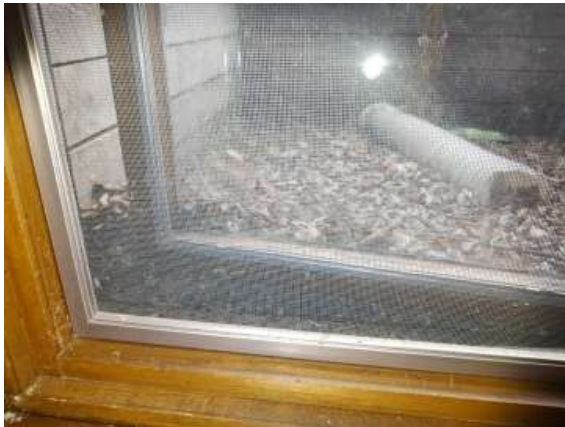
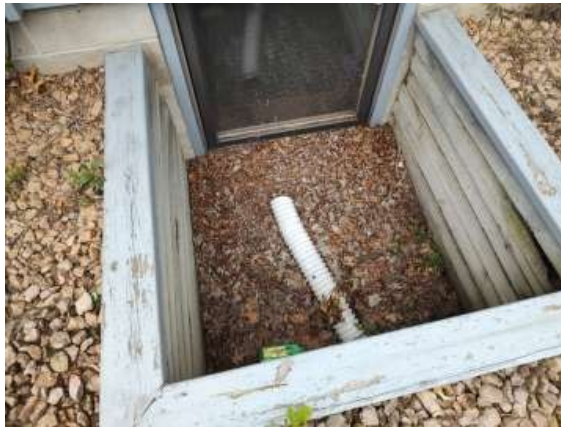
The timber retaining wall at the back side of the home has decayed significantly - and is in need of rebuilding / replacement.

The soil inside the timber retaining wall is touching the window sill, which means that the window is susceptible to moisture infiltration and decay (soil should be 4" below the sills).

There also are no covers installed over the window wells. Installing plastic covers over the window wells would help keep excess amounts of rainwater out.

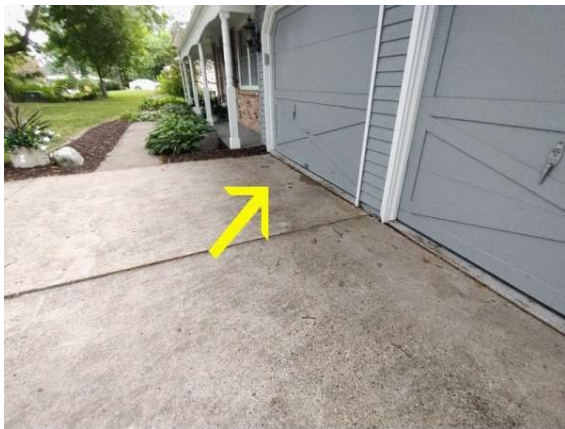
negative slope

The apron portion of the driveway has settled and is sloping toward the home, which allows water to accumulate against the foundation.

Eventually, the apron portion of the driveway will need to be replaced. All deteriorated block and voids in the soil can be remedied at that time (block can be core-filled for improved strength).

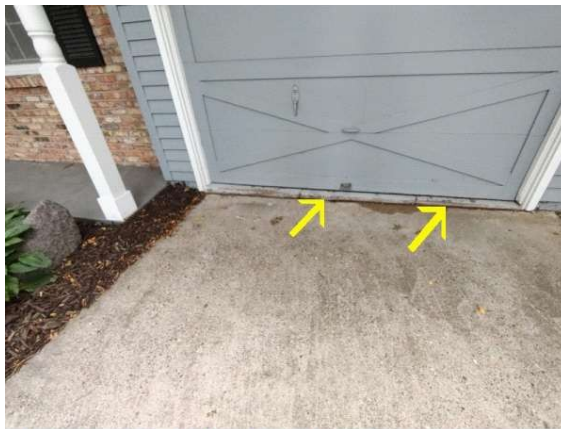
deteriorated block below slab

The foundation block (below the garage floor slab) has visibly deteriorated / eroded at some of these locations.

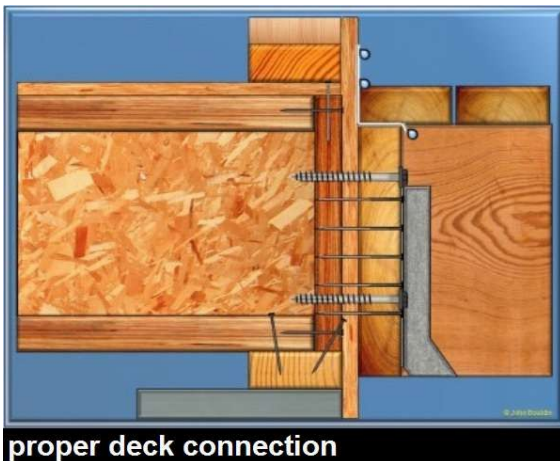
Most portions of the house connection were not evaluated, but the presence of flashing was confirmed. Verification of proper number of fasteners and proper installation was not made.

Bolts were not viewed at the one portion of the house connection that was visible (just one small portion was viewed).

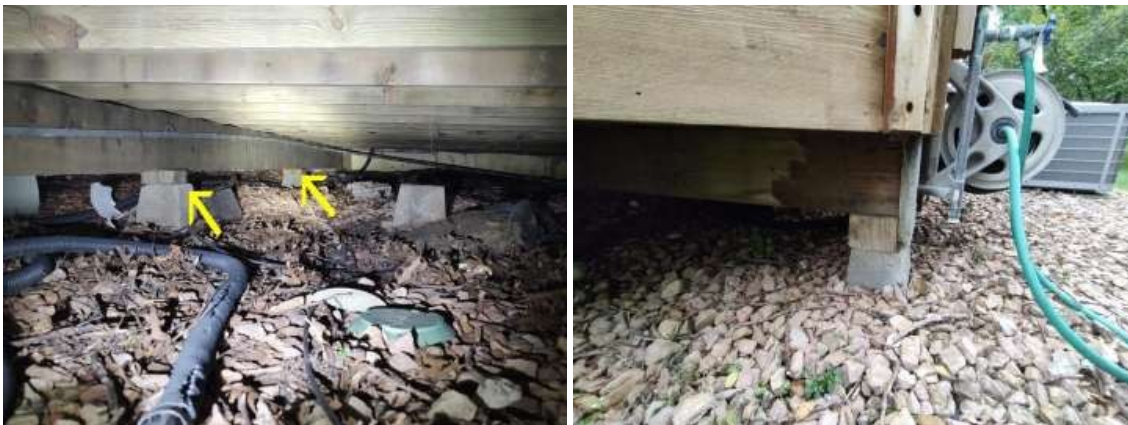
Temporary wood blocks / shims were used for vertical supports (between beams / footings), which is improper - and is evidence of non-professional work. No connections were used at the post / beam connections.

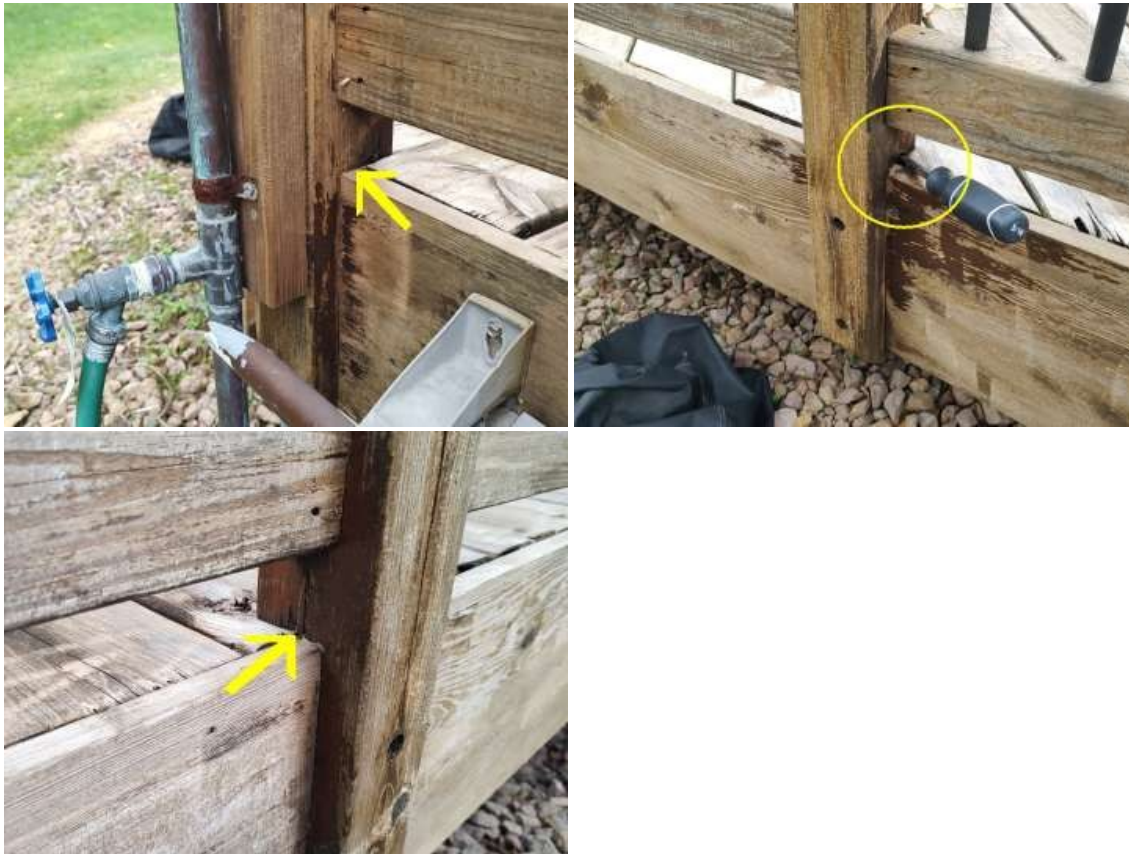
The posts were notched - where they connect to the floor structure. This is not recommended because it weakens the connections - and the cut areas are also very susceptible to decay. Decay was found at several of these locations. Replacement of the posts / rails will be needed in the future.

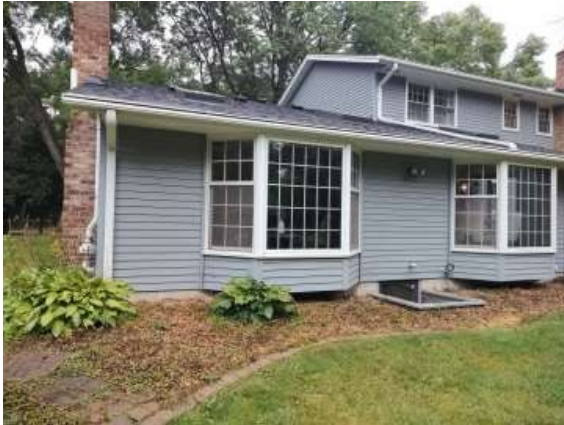
One large addition was made to this home. I suggest that you check with the City - and ask if permits were used during the construction.
