Inspection Address: 456 Sample Dr, MN 55555
Report: 9340 Inspection Date / Time: 9-9-2025,

PLUMBING

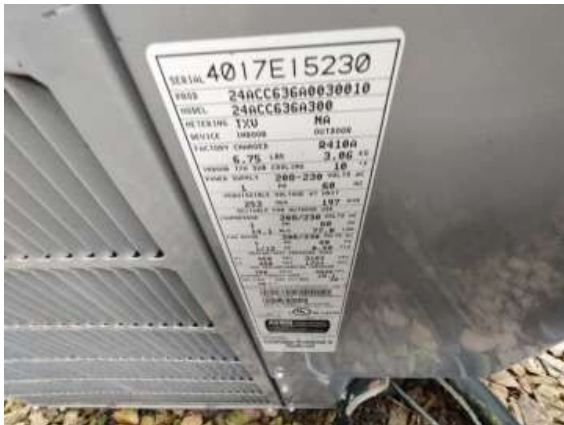
The air-conditioning system is operational and did produce the optimum air temperature drop of 15-20 degrees.

Supply air temp: 55 degrees.

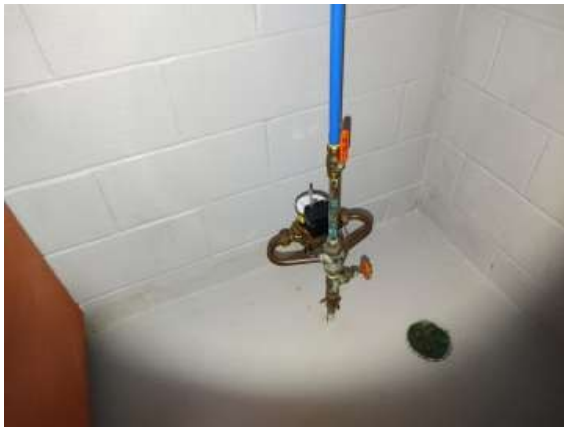
No problems noted.

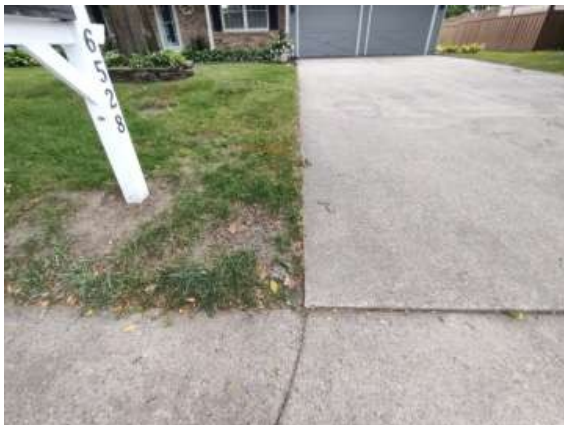
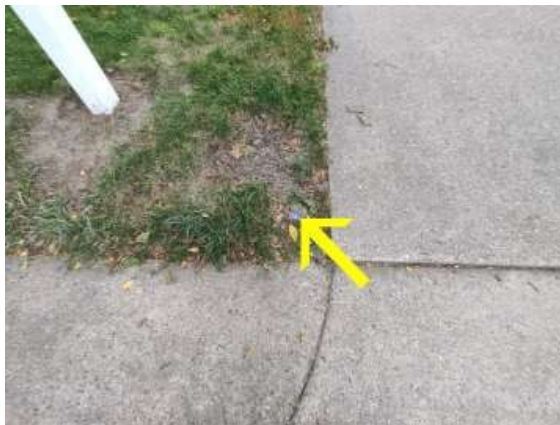
CURB STOP LOCATION:

Location of exterior shut off valve (curb stop).

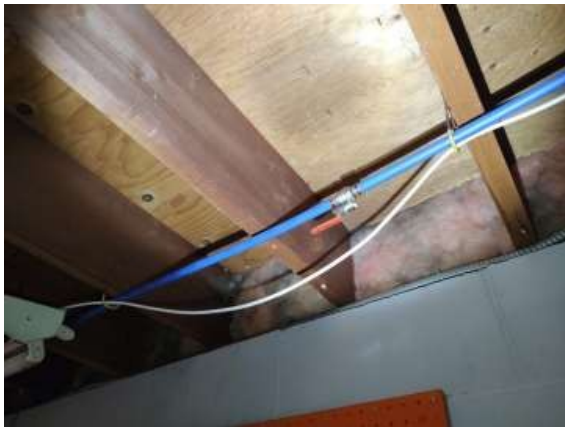
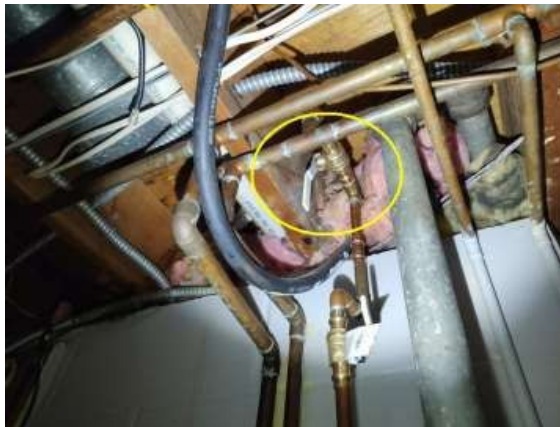
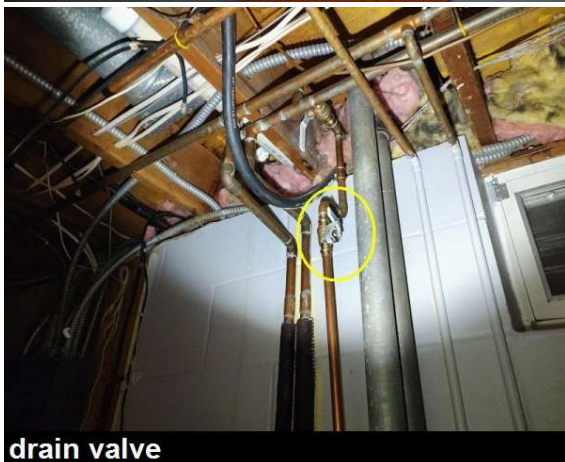
drain valve

Two shut off valves were located.

EVERY FALL: Before the first freeze, shut off the valves that supply water to the exterior spigots. Next, open the exterior spigots so the pipes can drain. Then, open the air petcocks (small cap located on the interior shut-off valve). This will allow air into the line, which will drain the remaining water out of the valve. Replace the petcock caps. It is smart to leave the spigot valve - at the house exterior - in the open position because this reduces the chances of freeze damage to the spigot components.

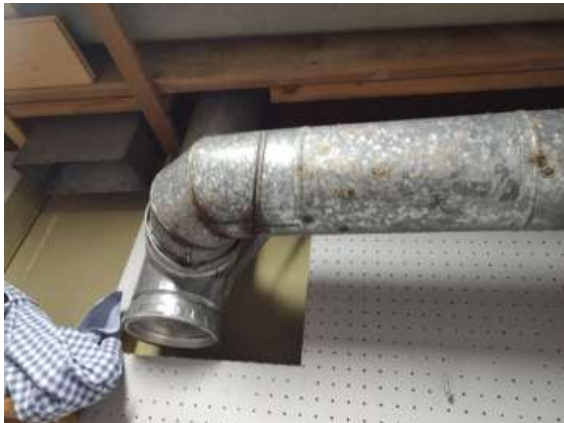
EXHAUST VENT & FLUE:

The exhaust vent has corroded / pitted where it connects to the vertical exhaust flue. Replacement of this portion of the exhaust vent is recommended.

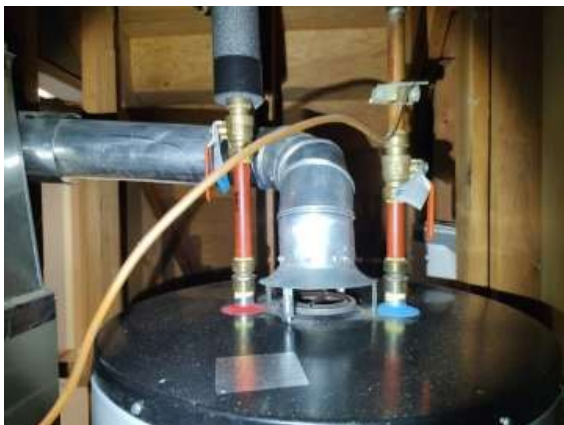
HOT/COLD PIPES:

The PEX plumbing is located too close to the draft hood (PEX plumbing should be at least 18" away from the draft hood). A different type of plumbing is needed at these locations (i.e. copper).

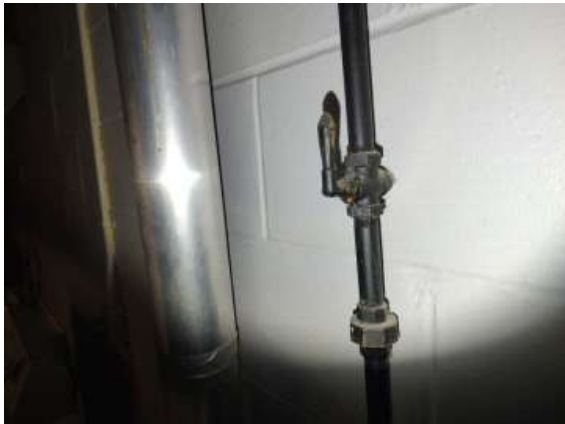
DRYER CONNECTION:

There is no sediment trap at the appliance connection.

The shut off valve is old, which means that it is more susceptible to leakage. Upgrading to a modern, AGA approved valve is recommended.

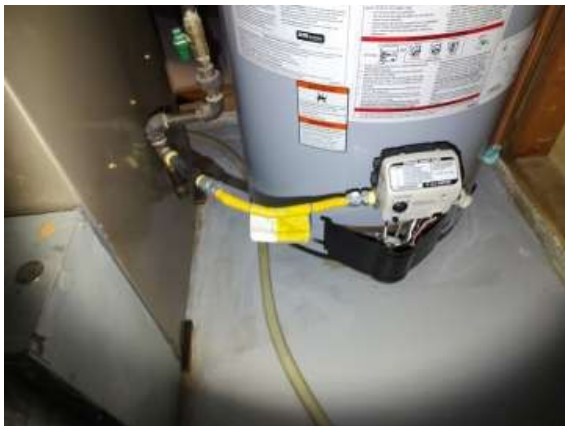
WATER HEATER CONNECTION:

A flexible pipe was used to attach the gas supply to the water heater. This material is not approved for water heater connections (rigid black iron, or soft copper are the only acceptable materials).

This generally indicates that the water heater was not installed by a licensed professional.
