Inspection Address: 123 Sample Blvd NE, MN 55555
Report: 9356 Inspection Date / Time: 9-29-2025,

CLIENT, SITE & OTHER GENERAL INFORMATION

REPORT #: 9356.	TYPE OF INSPECTION: Pre-Purchase Home Inspection.	PROPERTY INSPECTED: 123 Sample Blvd NE, MN 55555.	INSPECTION DATE: 9-29-2025.
CLIENT: Sample.	CLIENT E-MAIL: sample.com .	BUYER'S AGENT: Sample.	PEOPLE PRESENT: Buyers.

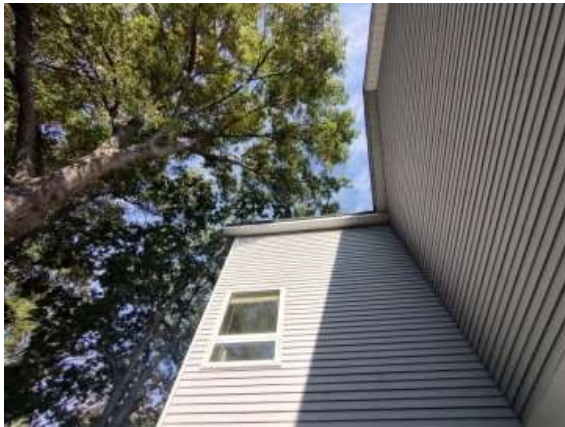
Some large tree branches overhang the roof. It is possible for branches to fall onto the home, which can damage the roof.

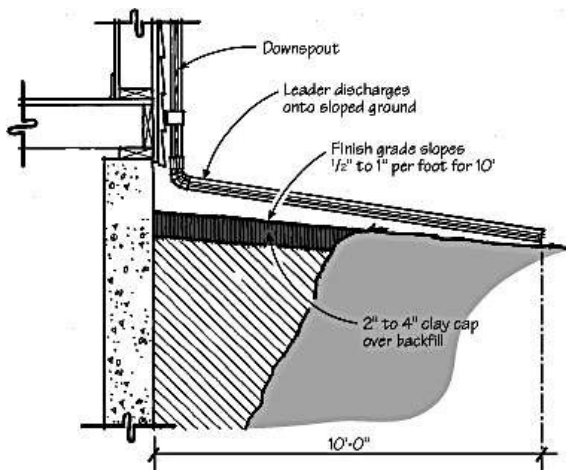
The grading is inadequately sloped away from the home at some locations (portions of front and right sides). A positive slope - for a minimum of 10', is recommended. Flat or negatively sloped grading allows rain water to accumulate near the foundation walls, which increases the chance for water to leak into the basement areas. Accumulating water can also erode the soil, or foundation over time.

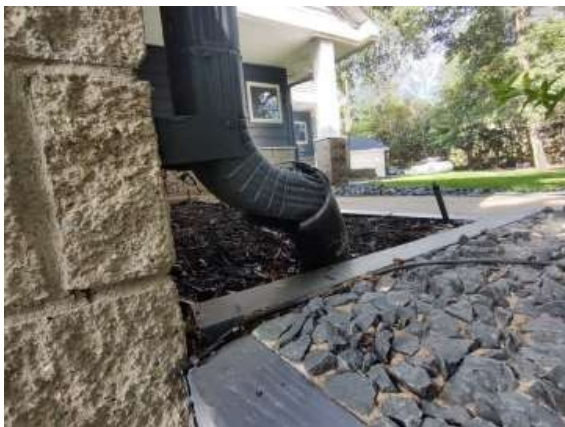
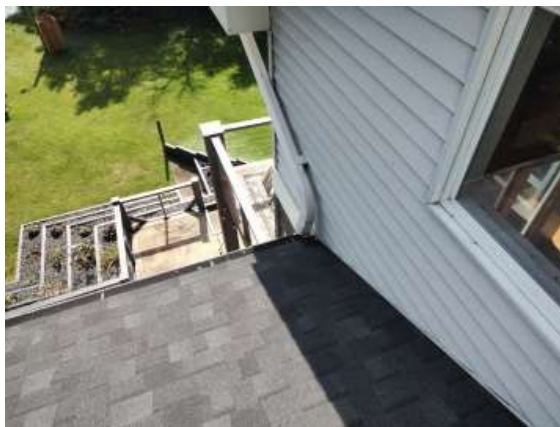
One downspout is not connected to its below-grade extension properly. This will allow water to pool against the foundation.

One downspout drains into a second story gutter, which will likely result in overflowing at this location.

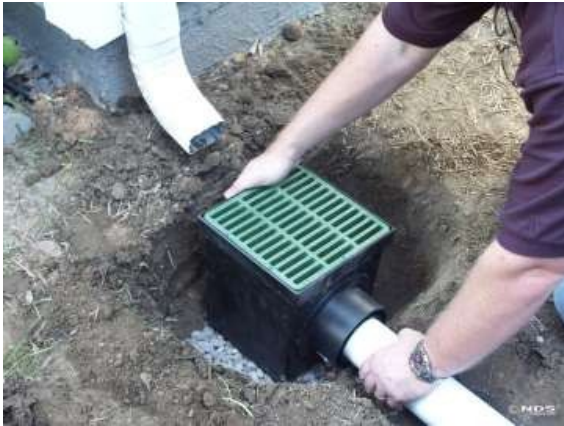
The downspouts connect directly to below-grade extensions. The concern with this design is that the underground portions can clog from debris, or from frozen water, which can allow water to back up and accumulate against the foundation (leaf guards do exist on the gutters - so this greatly decreases the concern).

A better alternative is to have the downspouts discharging to drain receptors (see photo). This design has an air gap between the downspout and below-grade extension.

Note: The terminations of the below-grade extensions were not located. Further evaluation is needed to ensure that all gutters are draining properly.

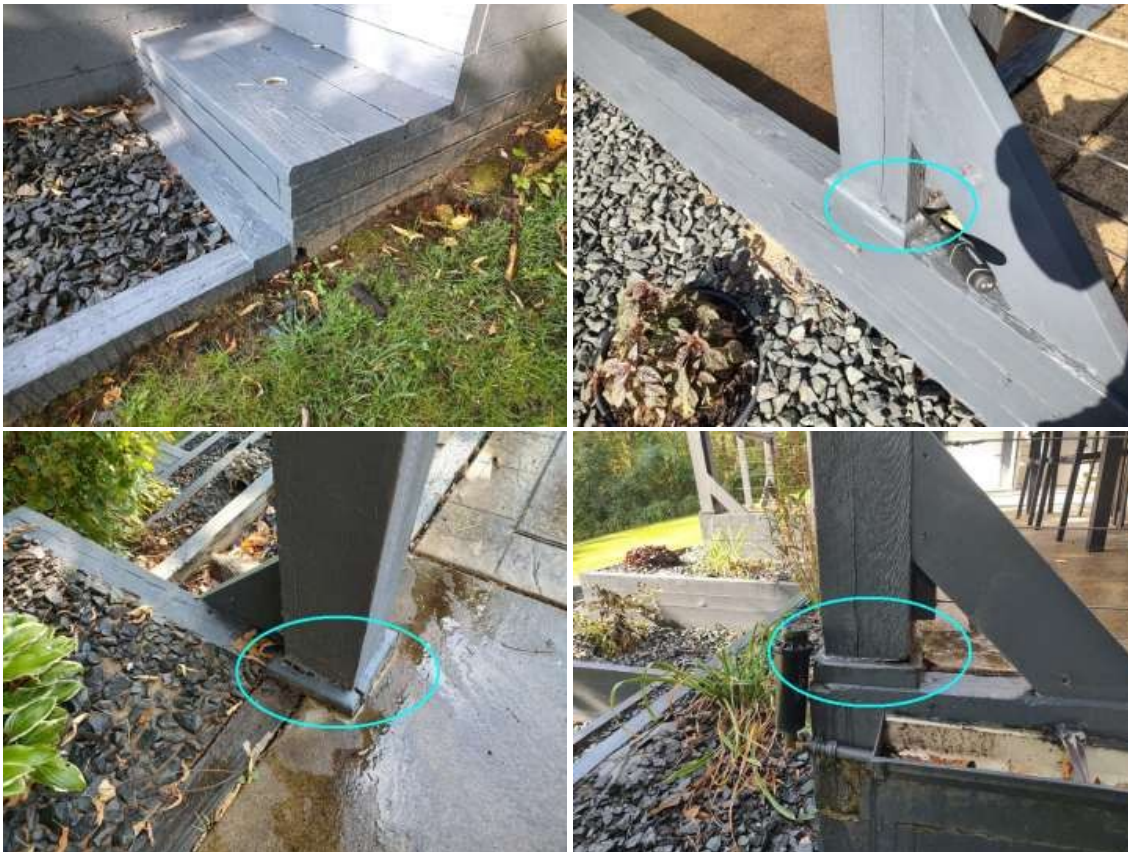
Several timber retaining walls and planters exist at the back side of the home - and several portions have decayed.

The bottom portions of the patio guardrail posts have also decayed.

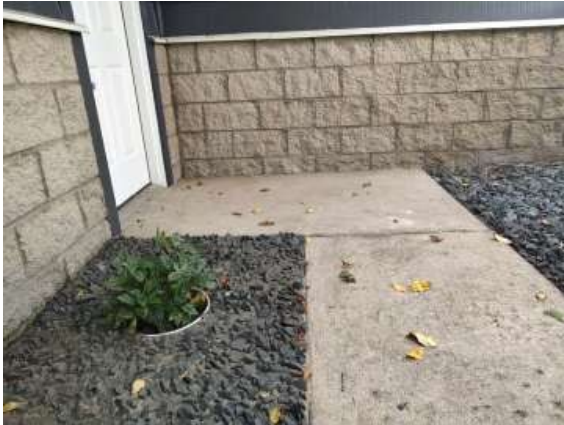
A portion of the walkway outside the exterior garage service door has settled and now slopes slightly toward the home. This will allow periodic rain accumulation against the foundation.

Mud-jacking / sand-jacking are the usual remedies.

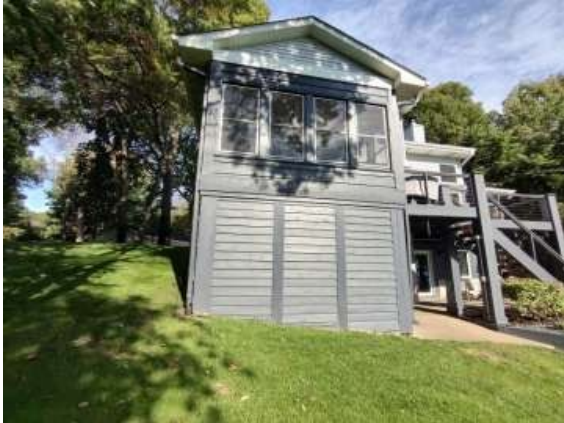
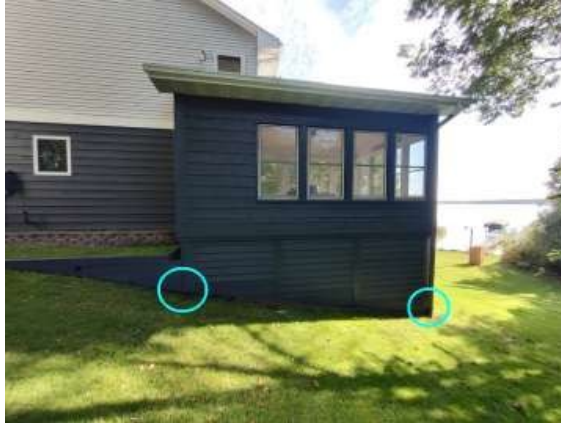
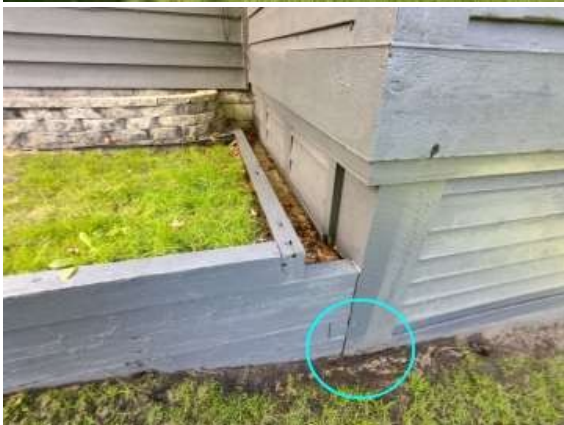
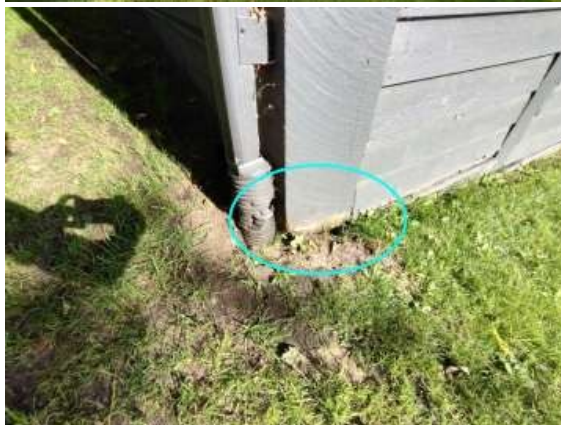
The bottom portions of all porch support posts have completely decayed. All posts are in need of replacement - and this should occur as soon as possible to prevent settlement of the porch structure.

The bottom portions of some deck support posts have also decayed. Note: The bottom portions of the deck posts are concealed with trim boards, so the full extent of decay could not be determined during the inspection. Further evaluation is needed - but the need for post replacement should also be anticipated at these locations.

Other portions of the porch trim / siding have also decayed (base of walls) - and gaps are present, which create pathways for pests / rodents to enter.

The footings will also need to be evaluated at the time of repair to ensure that they are properly sized.

Contact a licensed contractor for repair options and estimates.

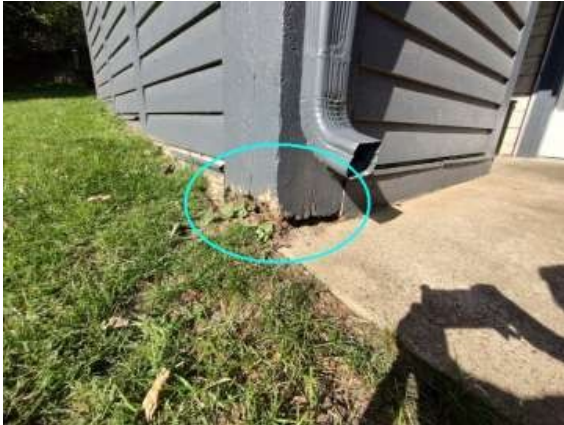
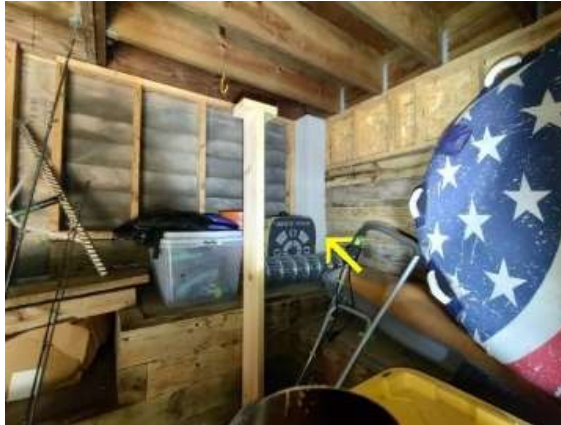
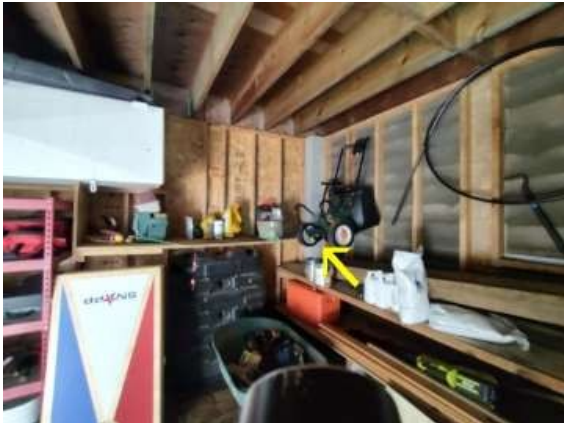
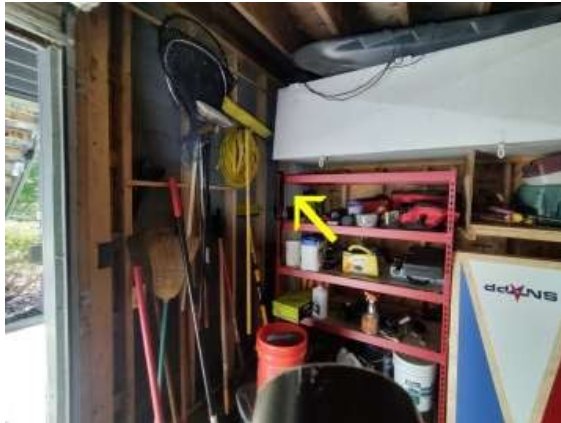
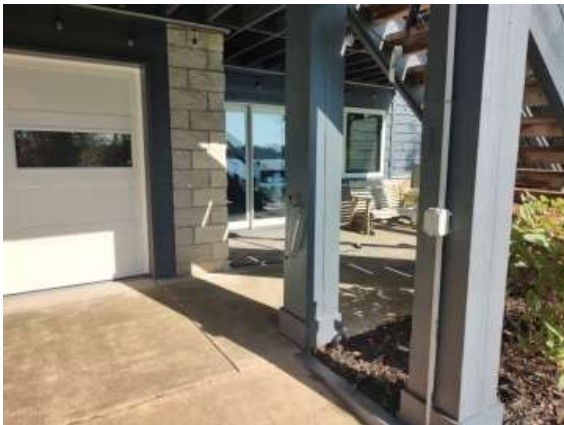
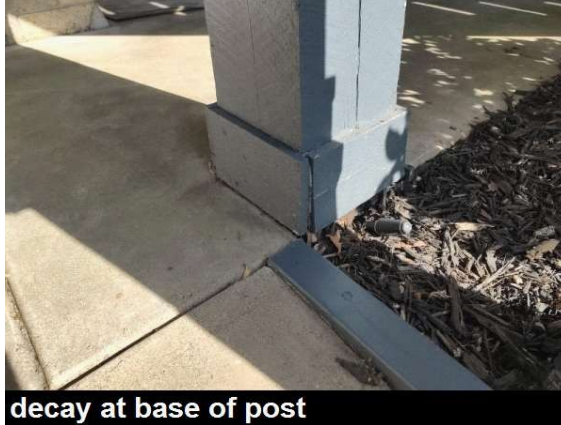
decay at base of post

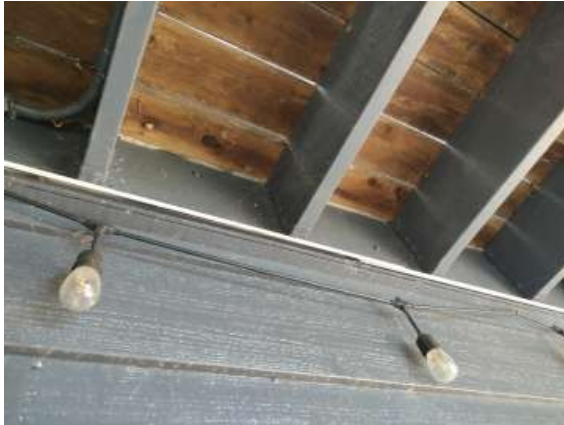
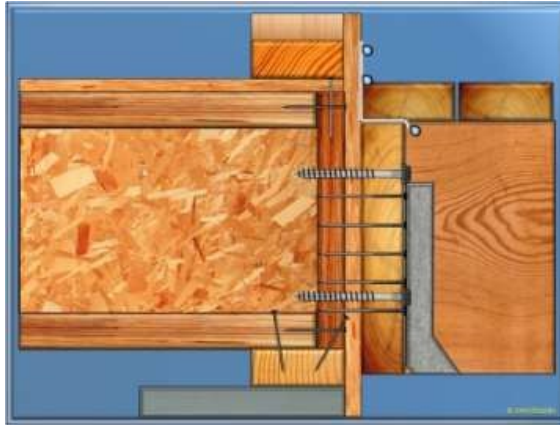
An inadequate number of bolts were used to anchor the ledger board to the home. This results in a weaker connection. The installation of additional bolts is recommended. Contact a licensed contractor for improvements.

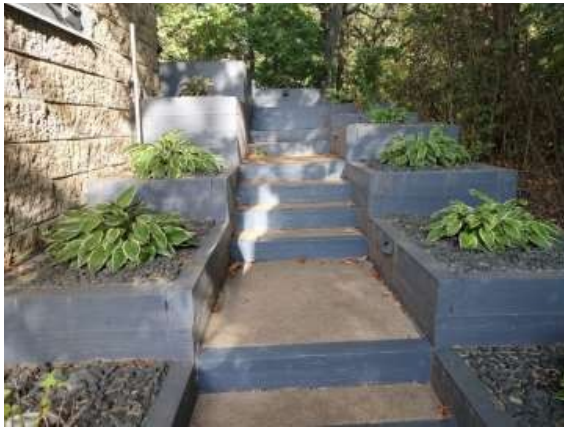
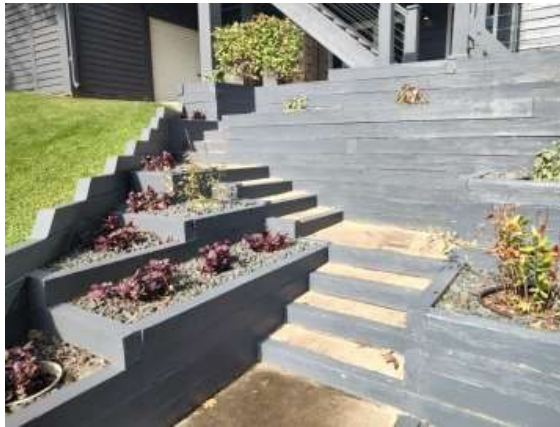
There are no handrails installed at the exterior staircases.
