Inspection Address: 456 Sample Dr, MN 55555  
Report: 9340 Inspection Date / Time: 9-9-2025,

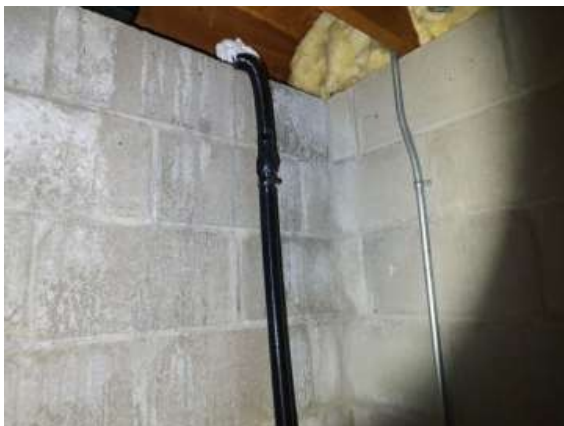
#### SUMP PUMP DISCHARGE PIPE:

A flex pipe / hose is used as the discharge pipe - including the portions at the house interior. This is not permitted because flex pipes are very susceptible to damage / cracking, which can result in leakage into the home.

The pipe is also excessively long at the house exterior, which will prevent water from draining properly.

I suggest that you replace this with a rigid, plastic pipe (1 1/2" diameter). Ideally, the pipe would extend at least 10' from the home (above or below grade).

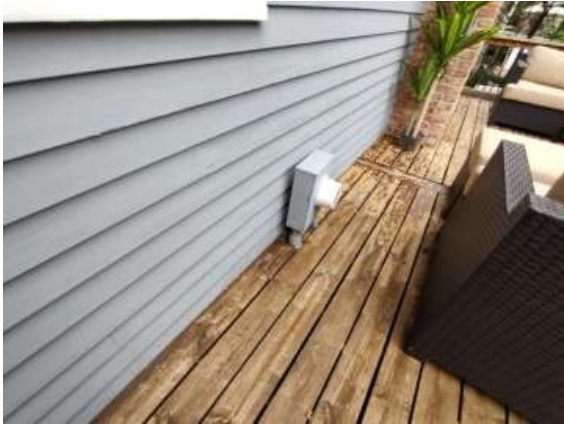
#### **UTILITY METER:**

The electric meter is positioned less than 44" above the grade, which is improper.

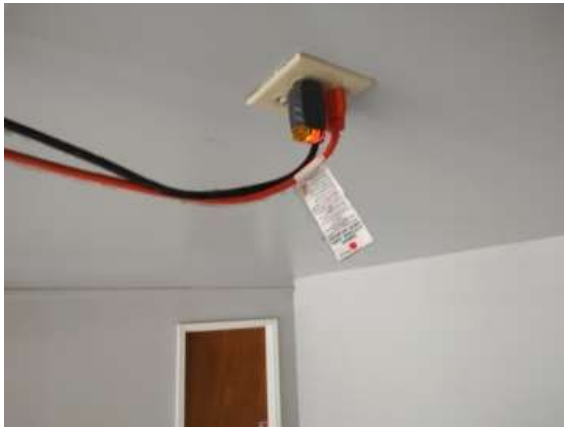
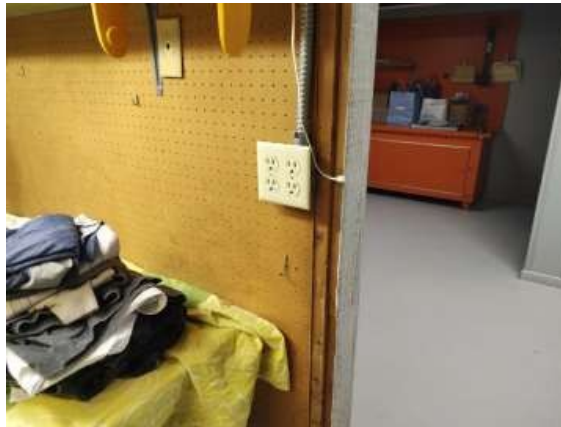
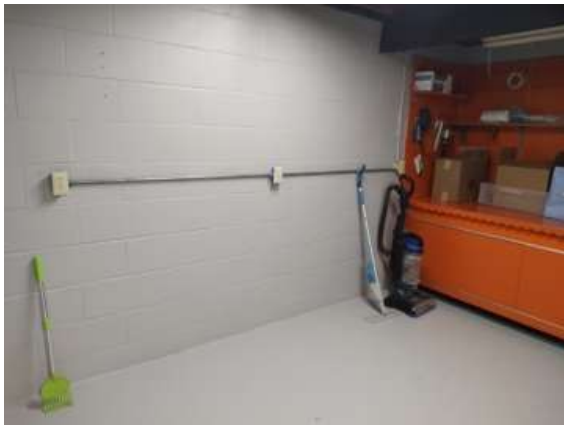
##### OUTLETS:

Reversed electrical polarity was detected at several basement workshop outlets - and also at the garage ceiling outlet. This condition creates potential shock hazards and even though the repair is typically simple, it should be conducted by a licensed electrician.

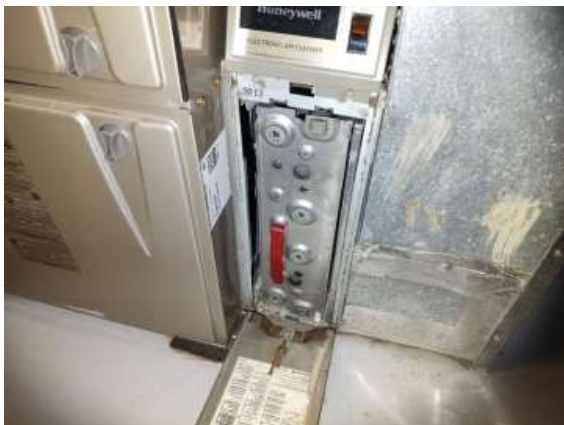
**AIR FILTERS - ELECTRONIC:**

The electronic filter is no longer operational - and is allowing unfiltered air to pass through the system.

The pre-filters are also badly damaged.

Complete removal of the filters is needed. Consider replacing these with a disposable 4" wide filter (these should generally be replaced every 3 - 6 months).

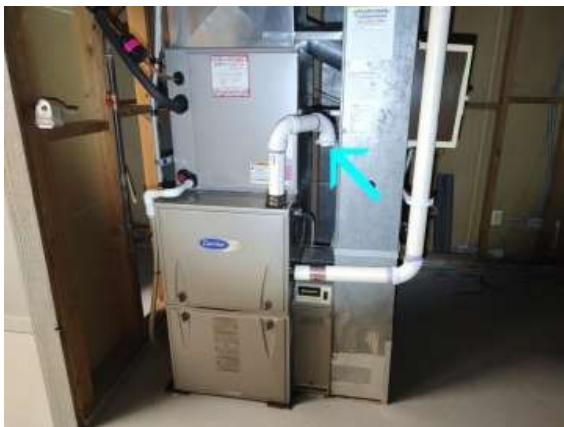
#### PLASTIC COMBUSTION AIR INTAKE PIPE:

Note: The combustion air source pipe does not extend to the house exterior, which means that all combustion air comes from inside the home (and from the make-up air source vent). For improved efficiency, this pipe can be extended to the house exterior, if desired.

In this case, a PVC pipe penetrates the rim joist area (below the deck). This is likely intended for an exterior air source of the furnace (pipe termination should telescope above the deck floor).

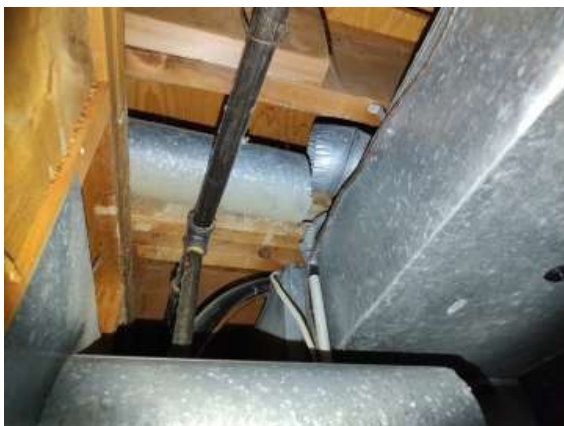
#### SUPPLY AIR DUCTS:

A supply air duct is disconnected - above the furnace.
