## **CONFIDENTIAL HOME INSPECTION REPORT**

Property Inspected:  
Sample St S., Cottage Grove, MN 55016

Prepared for: Sample  
Report Number: 5014A  
Inspection Date: 7-3-2010, 2:30 PM  
Inspected by: Tim Walz  
Suburban Home Inspections, Inc.  
[www.homeinvestigator.com](http://www.homeinvestigator.com)

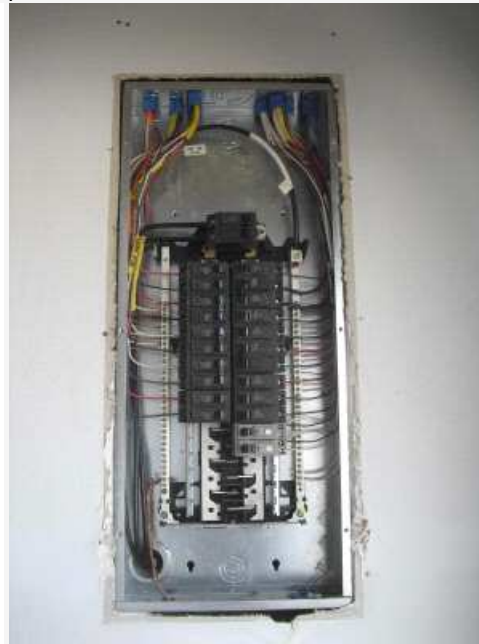
**MAIN PANEL:**

LOCATION: The main panel box is located in the garage.  
ELECTRICAL SYSTEM RATING: 120/240 Volt, 100-AMP: Minimum acceptable size.  
MAIN CIRCUIT BREAKER: SIZE: 100-AMP.  
BOX & COVER: No problems noted.

MAIN CIRCUITS: Copper.  
CIRCUIT BREAKERS: No problems noted.  
PANEL GROUND: No problems noted.

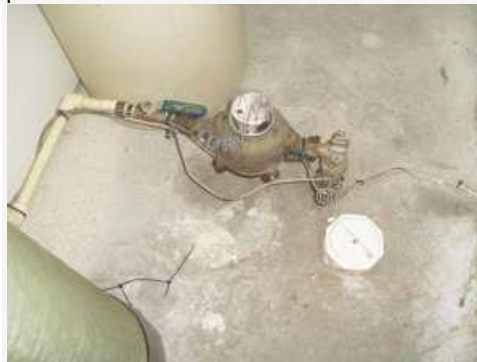
METER: No problems noted.

SHUT-OFF VALVES: No problems noted.

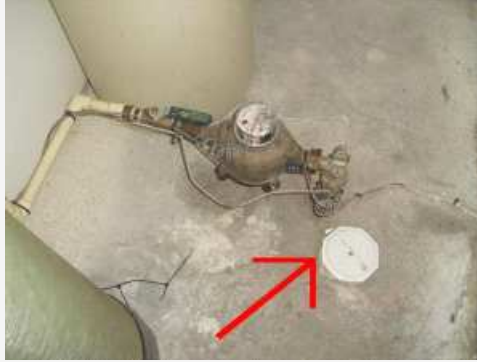
**DRAIN, WASTE & VENT PIPES:**

MATERIAL(S) USED: Plastic.  
CONDITION: Most portions of the drainpipes were not visible.  
CLEANOUTS: No problems noted.

FLOOR DRAIN: No problems noted.

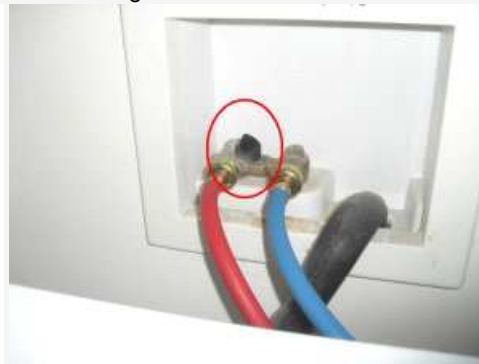
This washing machine has a singular shut-off valve, which should be shut off when the appliance is not in use. This will relieve the pressure from the hoses, which reduces the odds of a leak occurring.
