## REMAINING INTERIOR PORTIONS

Inspection Address: 456 Sample Dr, MN 55555  
Report: 9340 Inspection Date / Time: 9-9-2025,

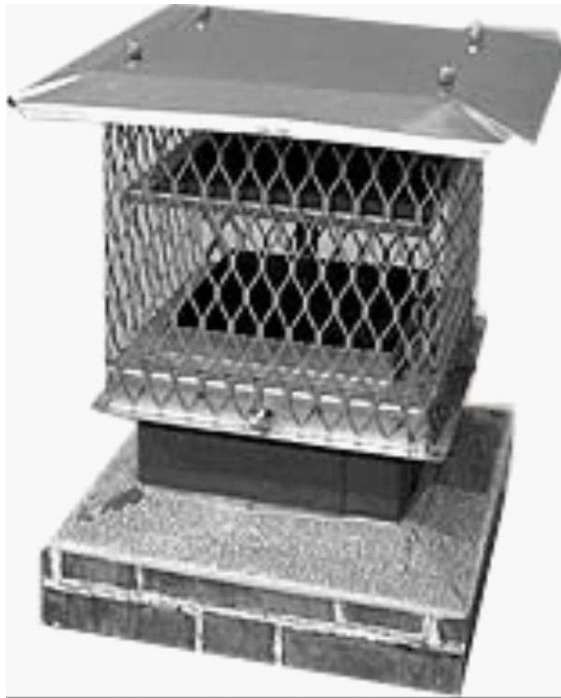
**proper design for external damper**

Note: One of the dampers is damaged and is no longer operational (first floor living room fireplace). This damper is stuck in the open position, which allows a pathway for pests to enter. Complete removal of this damper is recommended (cover should be replaced - and a standard cover could be used).

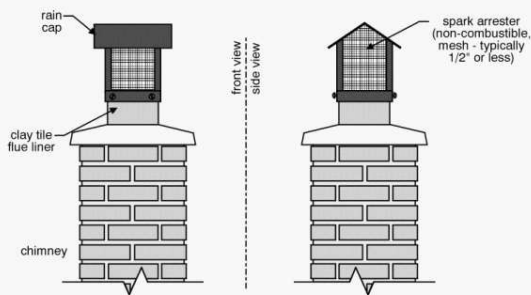
**basic covers**
