Inspection Address: 123 Sample Blvd NE, MN 55555
Report: 9356 Inspection Date / Time: 9-29-2025,

HEATING & COOLING SYSTEMS

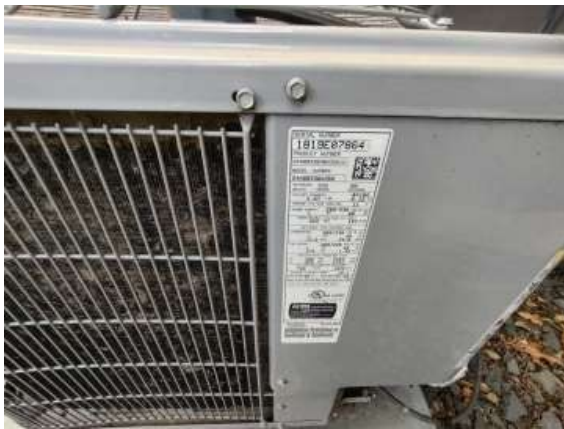
APPROXIMATE AGE:
The air-conditioner is approximately 6 years old.
Average lifespan: 20-25 years.

MANUFACTURE DATE:
2019.

REFRIGERANT TYPE:
R-410A.

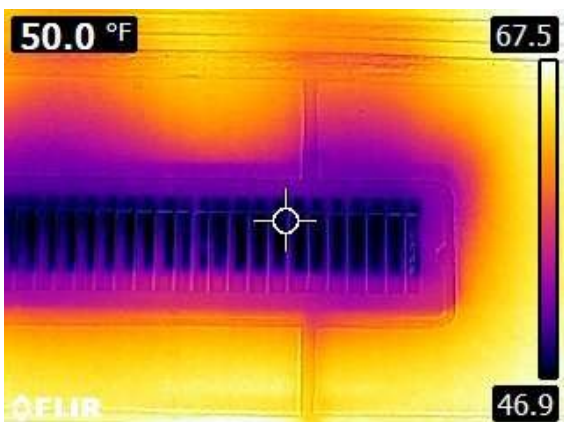
The air-conditioning system is operational and did produce the optimum air temperature drop of 15-20 degrees.

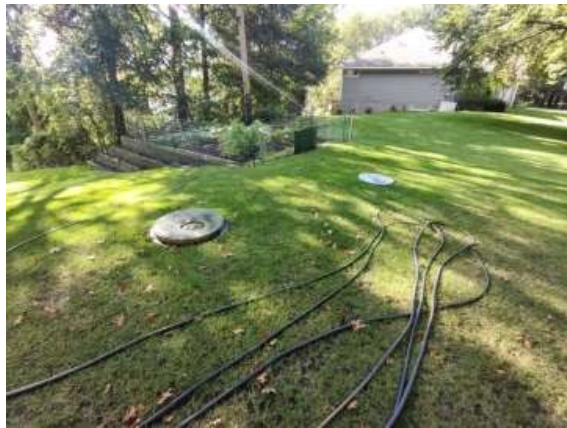
No problems noted with the operation of the unit at the time of the inspection.
