Inspection Address: 123 Sample Blvd NE, MN 55555  
Report: 9356 Inspection Date / Time: 9-29-2025,

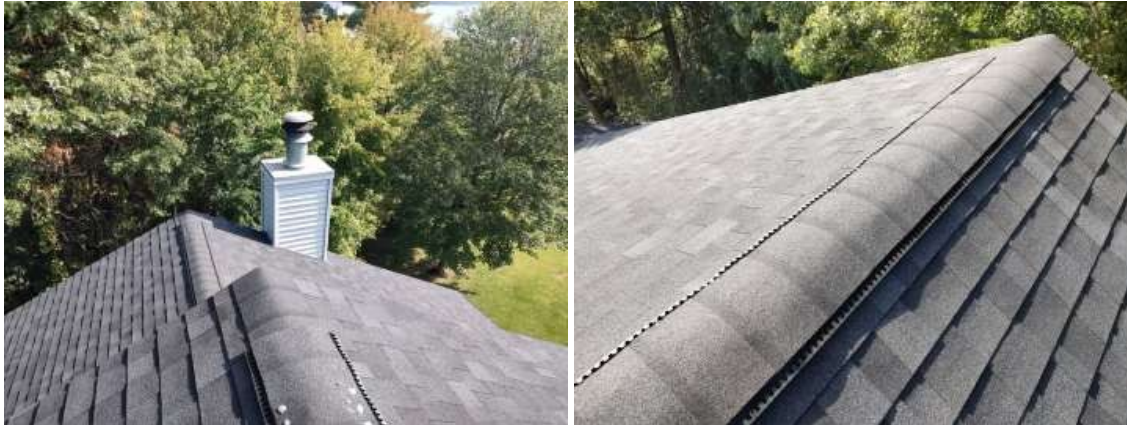
The inspection was performed from the rooftop (roof was walked).

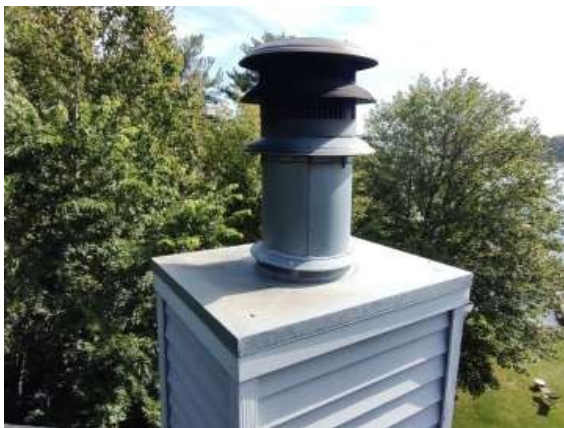
**stained sheathing below chimney**

There is no diverter at the base of the chimney chase (see photos). This allows rain water to drain against the siding - and the gap at this location has allowed water to drain behind the siding. Some amount of concealed damage to the wall sheathing - below this location - has likely occurred.

Stains do exist on portions of the roof sheathing below this area (visible from inside attic space).
