Inspection Address: 456 Sample Dr, MN 55555
Report: 9340 Inspection Date / Time: 9-9-2025,

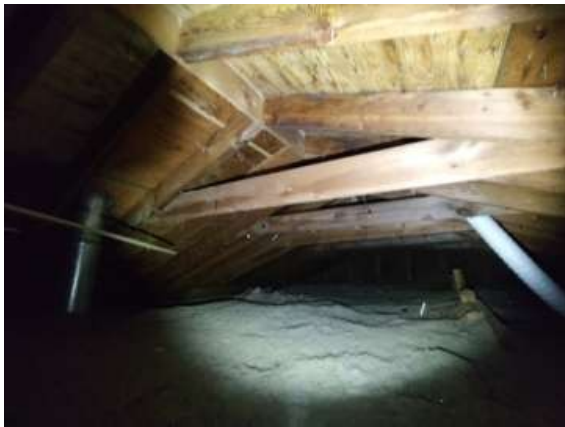
There is an inadequate amount of insulation secured to the back side of the attic hatch (rigid foam insulation is preferred). This allows a large amount of heat loss to occur at this location.
