Inspection Address: 456 Sample Dr, MN 55555  
Report: 9340 Inspection Date / Time: 9-9-2025,

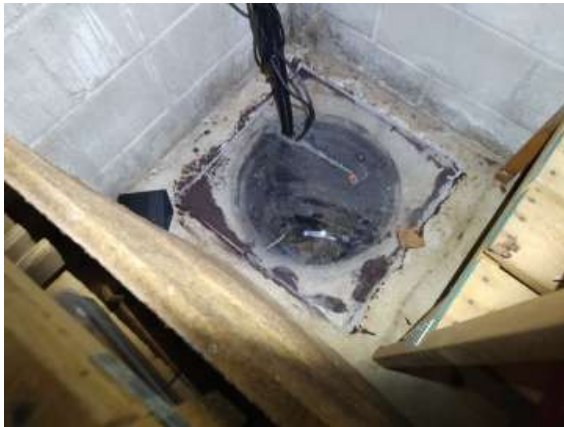
#### SUMP PUMP DISCHARGE PIPE:

A flex pipe / hose is used as the discharge pipe - including the portions at the house interior. This is not permitted because flex pipes are very susceptible to damage / cracking, which can result in leakage into the home.

The pipe is also excessively long at the house exterior, which will prevent water from draining properly.

I suggest that you replace this with a rigid, plastic pipe (1 1/2" diameter). Ideally, the pipe would extend at least 10' from the home (above or below grade).

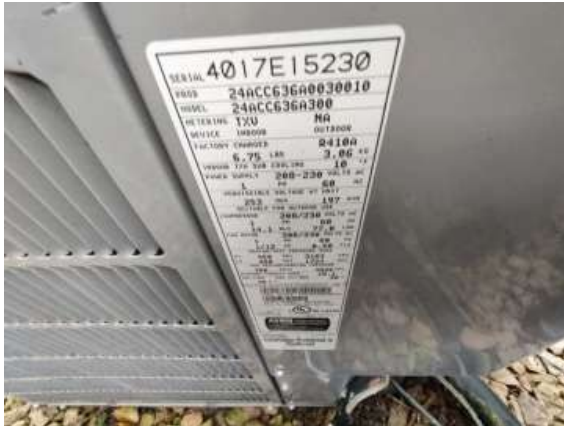
#### AIR CONDITIONING PERFORMANCE & COMPONENTS:

The air-conditioning system is operational and did produce the optimum air temperature drop of 15-20 degrees.
